# **Enquiry Committee Report**

## **Major Fire at ONGC Hazira Plant On 24.09.2020**

# **Detailed Report of Enquiry Committee constituted by PNGRB to investigate the major fire occurred at ONGC Hazira Plant on 24.09.2020**

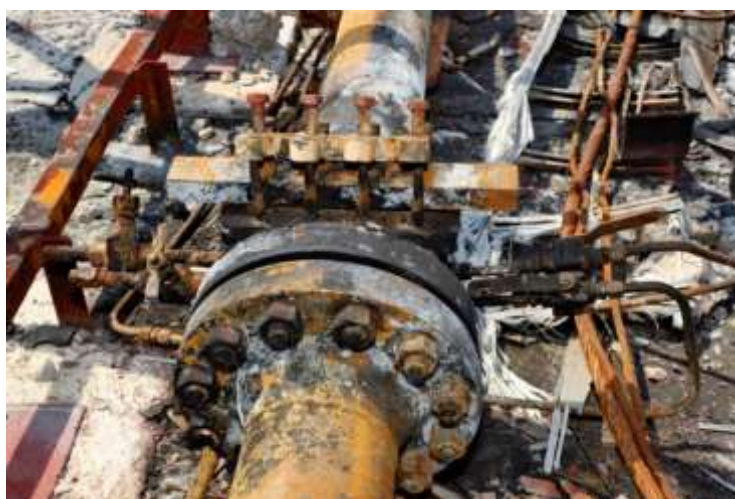
(a). Damaged plate of meter 310FT01

On 18.09.20, when upstream valve was opened by operations and maintenance teams, leakage was observed from meters. The meter is very old (1986) and having rectangular slot for the gasket. Original Specifications of gasket are not available, and the gaskets were not being procured from the OEMs. Instead, use of locally purchased 'O' ring was done in its place as a regular practice. There was no specification or quality control during the purchase of the 'O' rings. There is no record of date or authority of the decision to switch over from OEM supplied gasket to locally purchased gasket.

For the same meter, these 'O' ring gaskets were replaced on 12.11.2018 and 25.02.2019. After calibration of the meter 310FE01, the gasket was replaced on 18.09.2020. No hydro test was done after replacement of the gasket. The system was only pressurised to operating pressure (Both meters were in line) and isolated. Next day meter 310FE01 was taken on online and was in use at the time of Incident.

Probable cause of leak is due to use of nonstandard gasket and not testing the system to designed pressure. No standard operating procedure is in place for calibration and taking back in service of these meters which are operating at high pressures.

- i. During calibration of meters/ other instruments, details of Master calibrator / action taken/ replacement/ deviation from procedure if any, is to be documented in the calibration certificate.
- ii. Proper SOP is to be developed along with checklist for maintenance work on high pressure gas/ liquid pipelines metering system.

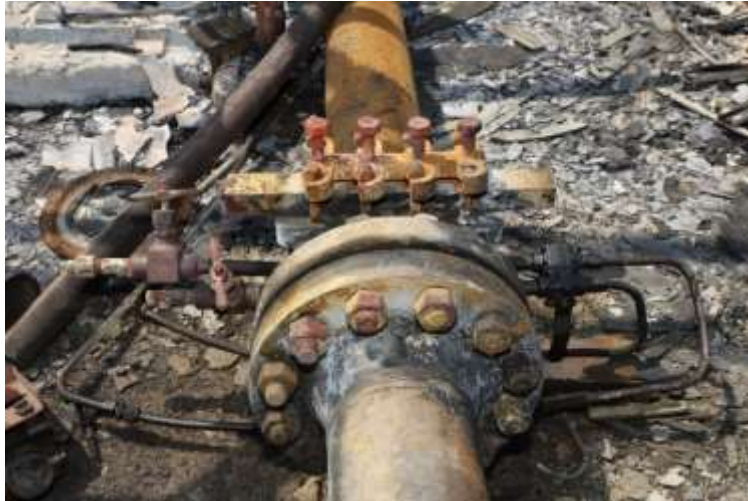
(b). Plate of meter 310FT02 in place

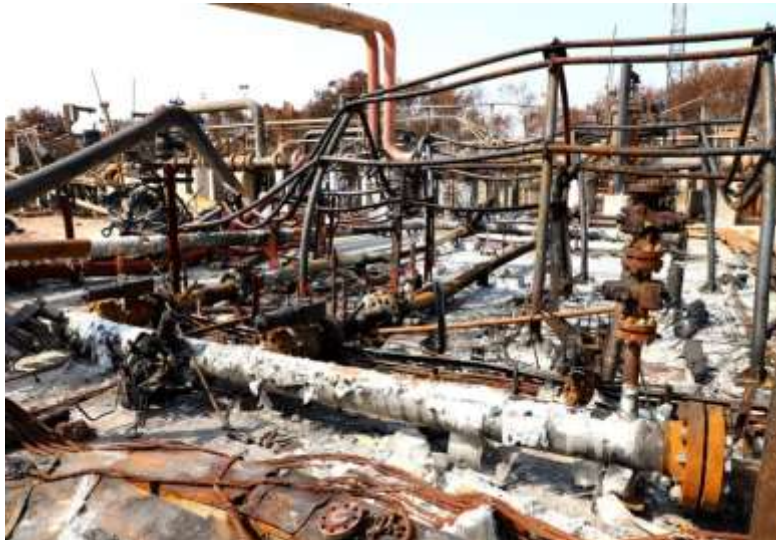
(c). Damaged pipelines

The site was inspected, and it was observed that the condensate metering skid was totally damaged & various pipelines have got damaged/ shifted. In condensate metering system, two 6" size meters & one 2" size meter are provided. 6" meter with ID 310FE1 was extensively damaged with all bolts out of the flange arrangement and only one bolt damaged for 310FE2 (6" size). The condensate might have leaked from the meter 310FE1. Leakage from pipeline due to corrosion/flange leak from other sources could not be ascertained due to total damage of the pipelines in the area.

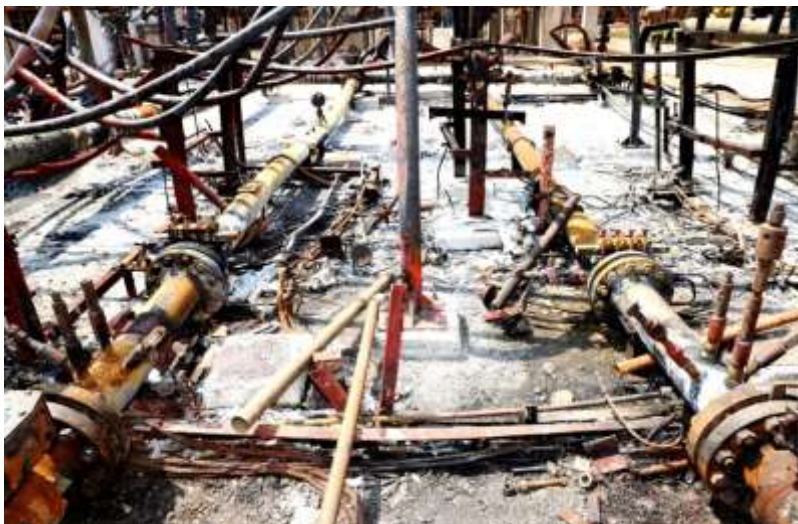
(d). Overview of both meters of condensate pipelines

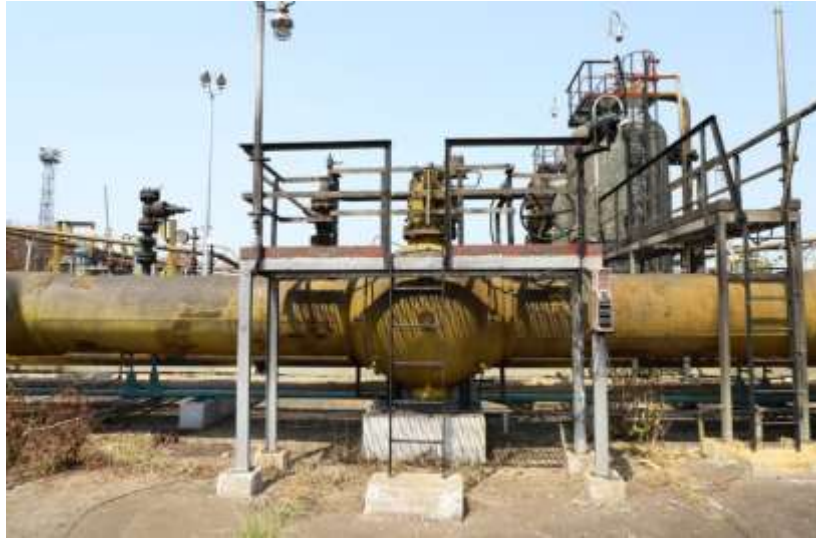
(e). Gas pipeline view

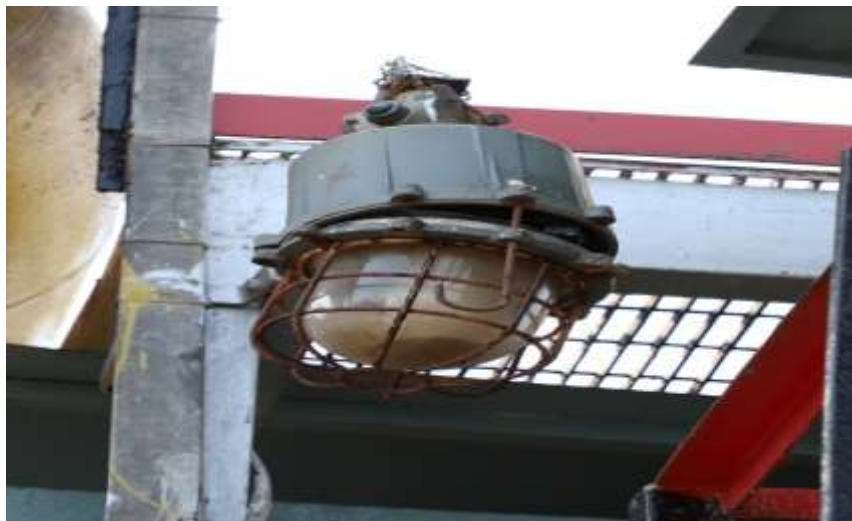
(f). Open FLP fitting (probable ignition source)

On inspection of electrical fittings, it was observed that three bolts on one of the flame proof lamps were missing resulting in it being open with its integrity compromised, glass case got detached from the main body and had opened out about 5 to 6 cms. The nearby fittings were found intact. Proper identification of these light fittings/ junction boxes/ etc. is not available. General Data on preventive maintenance and number of fittings/ bulbs replaced is available. No electrical Audit is conducted. The schedule for the inspection is six monthly. Last inspection was carried out in July 2019. No inspection carried out in schedule of April 2020. The closure of work notification is also very brief without any details. As the fire had happened at 0300 hrs and no traces of fire beyond the road inside the plant, the origin of Fire is within Plant only. Therefore, it is concluded that cause of fire is ignition source from electrical fittings.

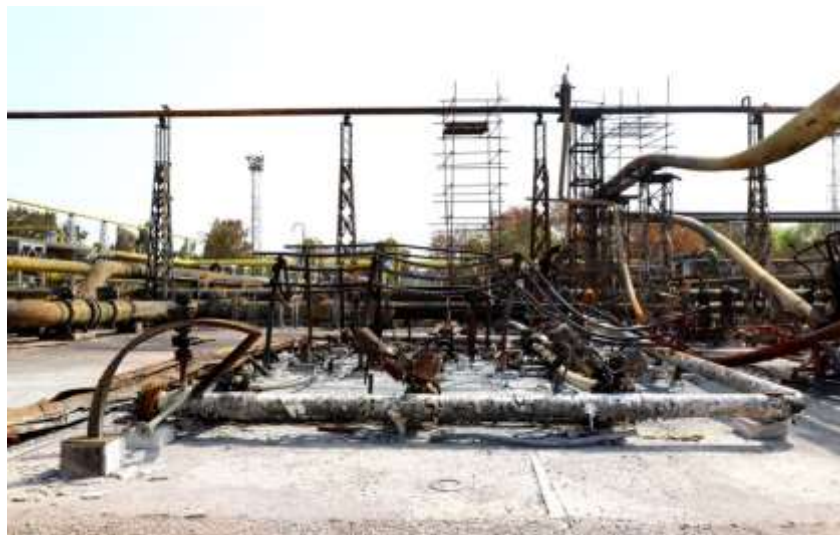
(g). Damaged condensate metering area

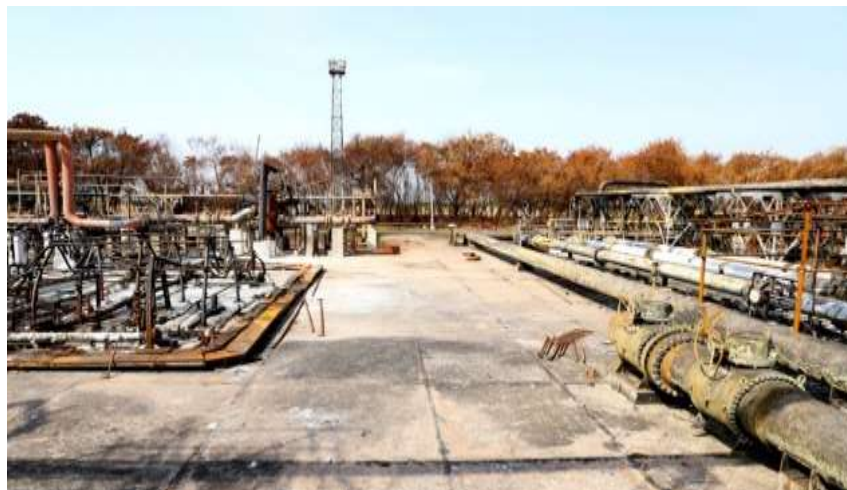
(h). Overview of part area with tower where CCTV is provided

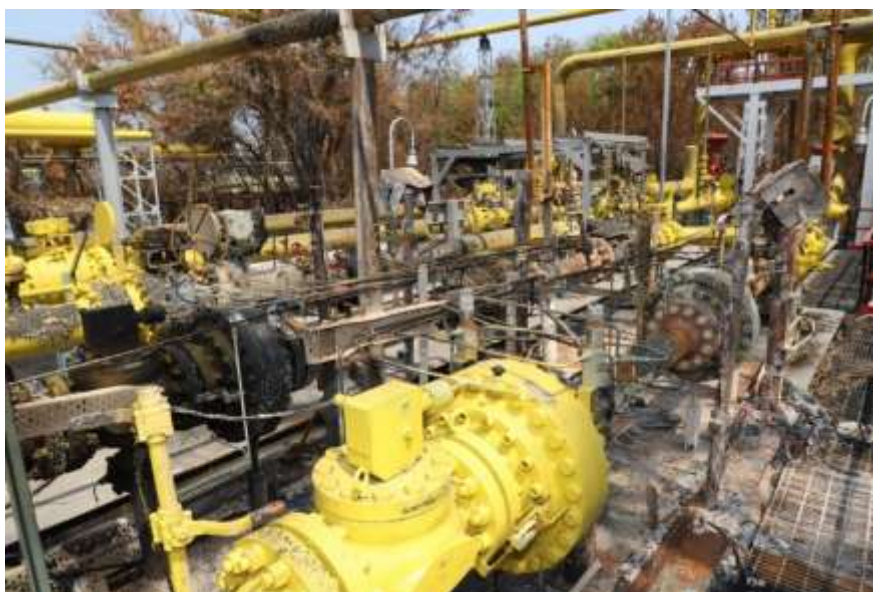
(i). Damaged pipelines/structures

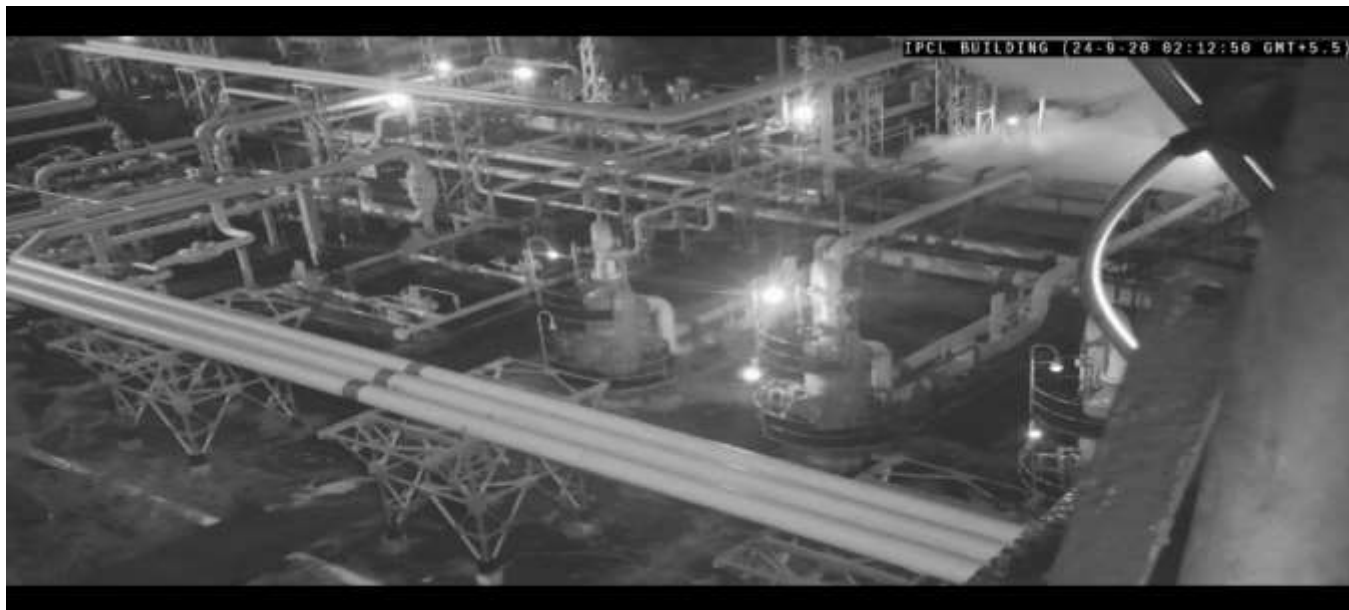
(b). Time – 02:12:50 (Dated 24.09.2020), Commencement of Vapour leakage

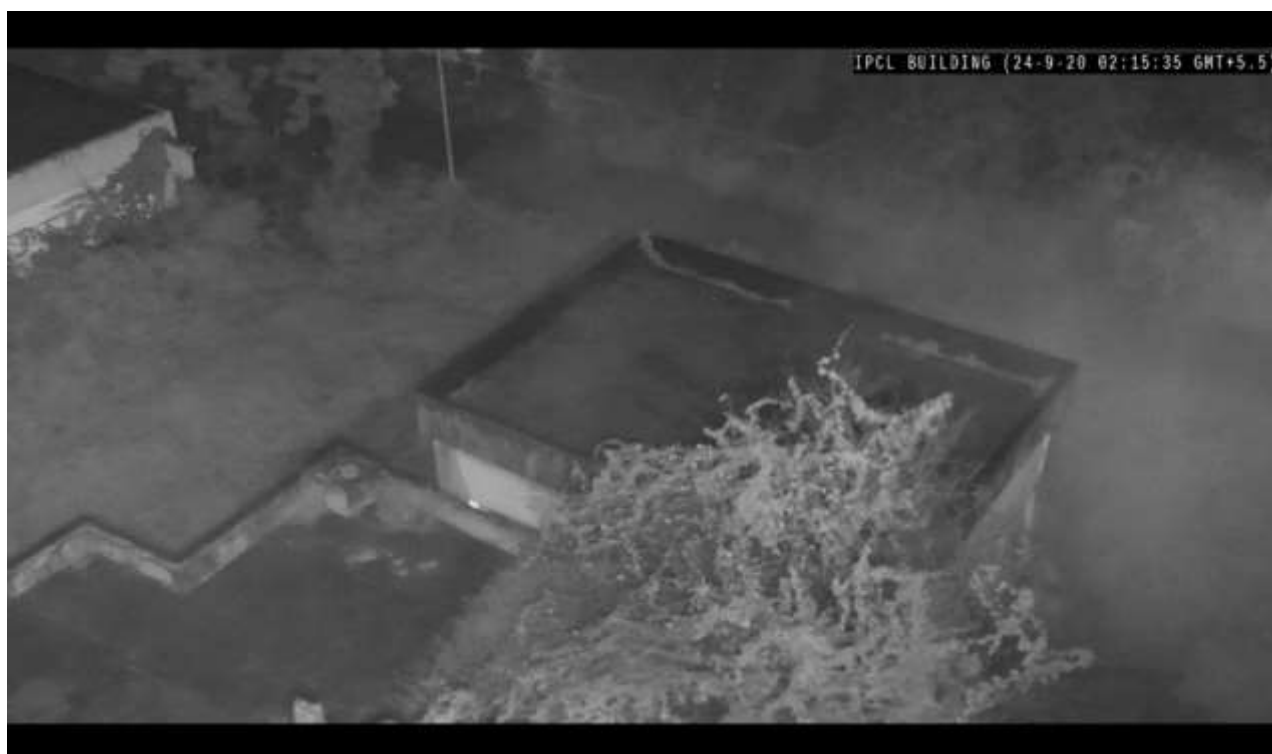
(c). Time – 02:15:35 (Dated 24.09.2020), Vapour cloud near GT control room

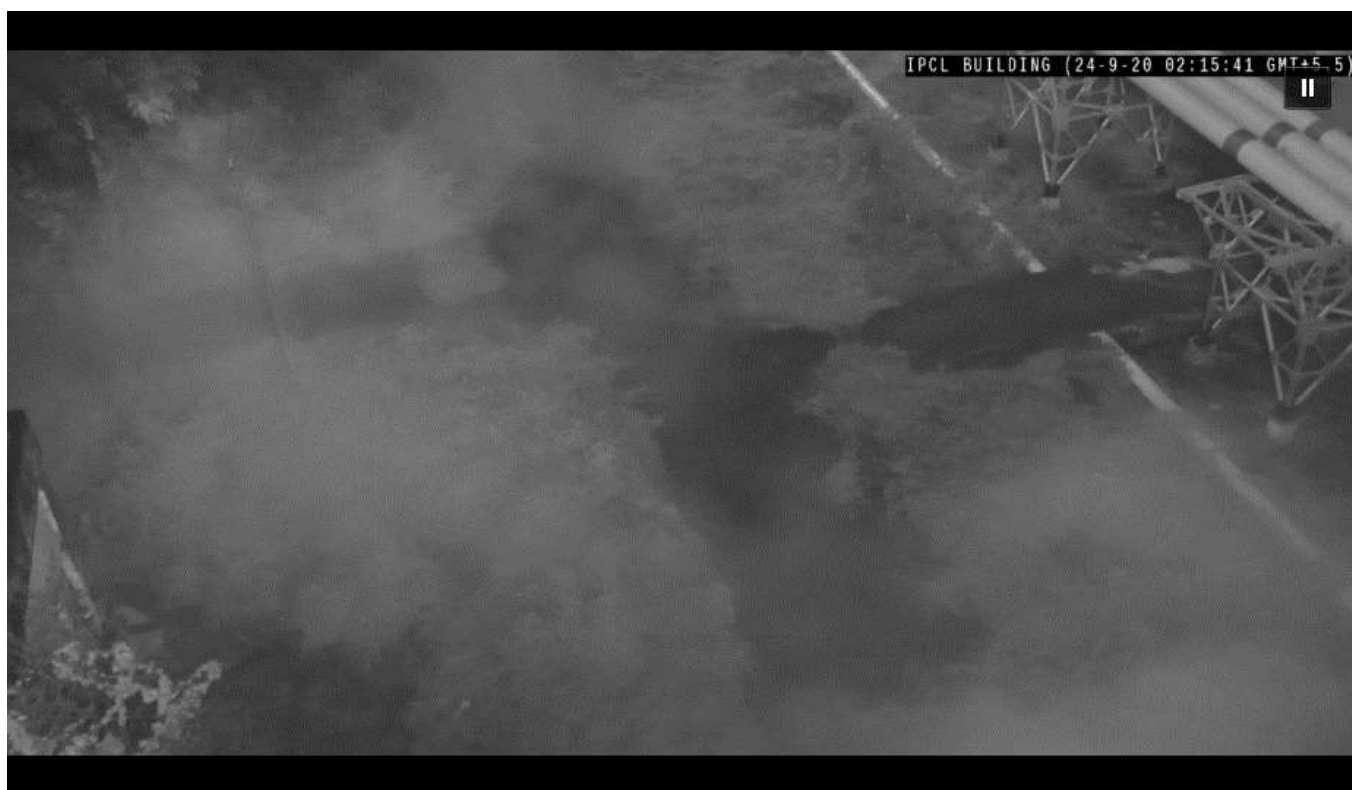
(d). Time – 02:15:41 (Dated 24.09.2020), vapour cloud on road near GT control room

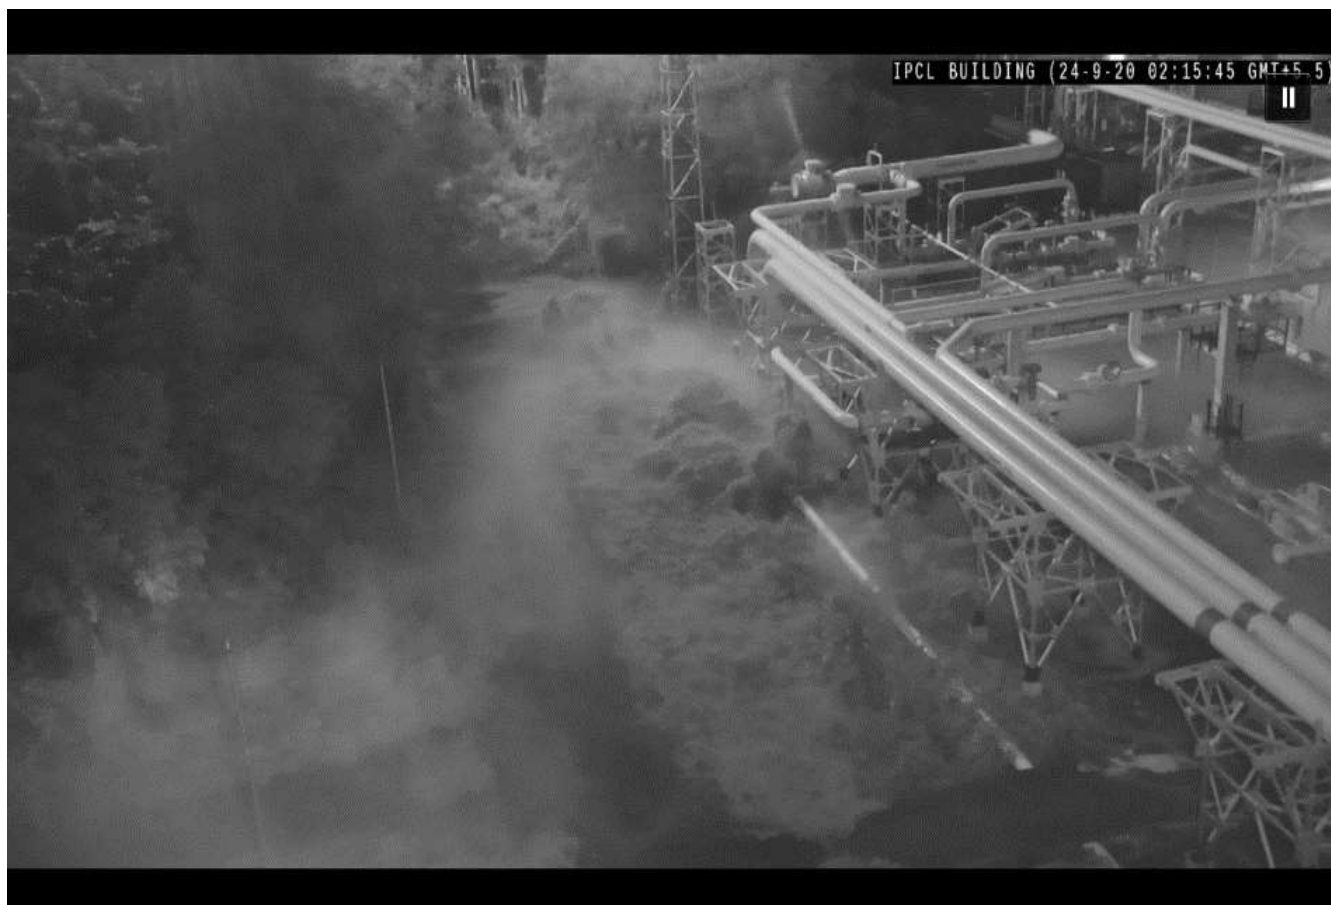
(e). Time – 02:15:45 (Dated 24.09.2020), vapour cloud in piping area

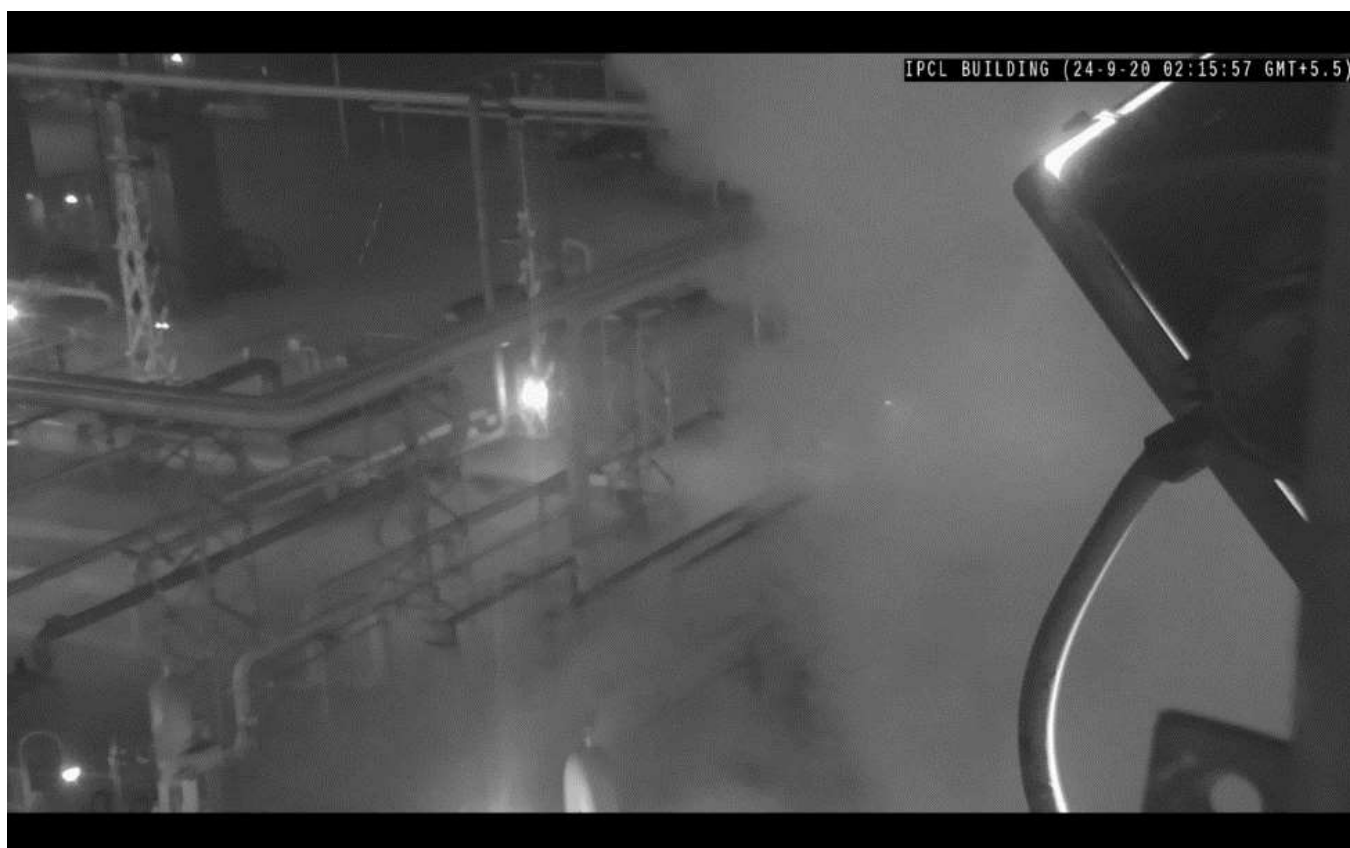
(f). Time – 02:15:49 (Dated 24.09.2020), vapour cloud increased

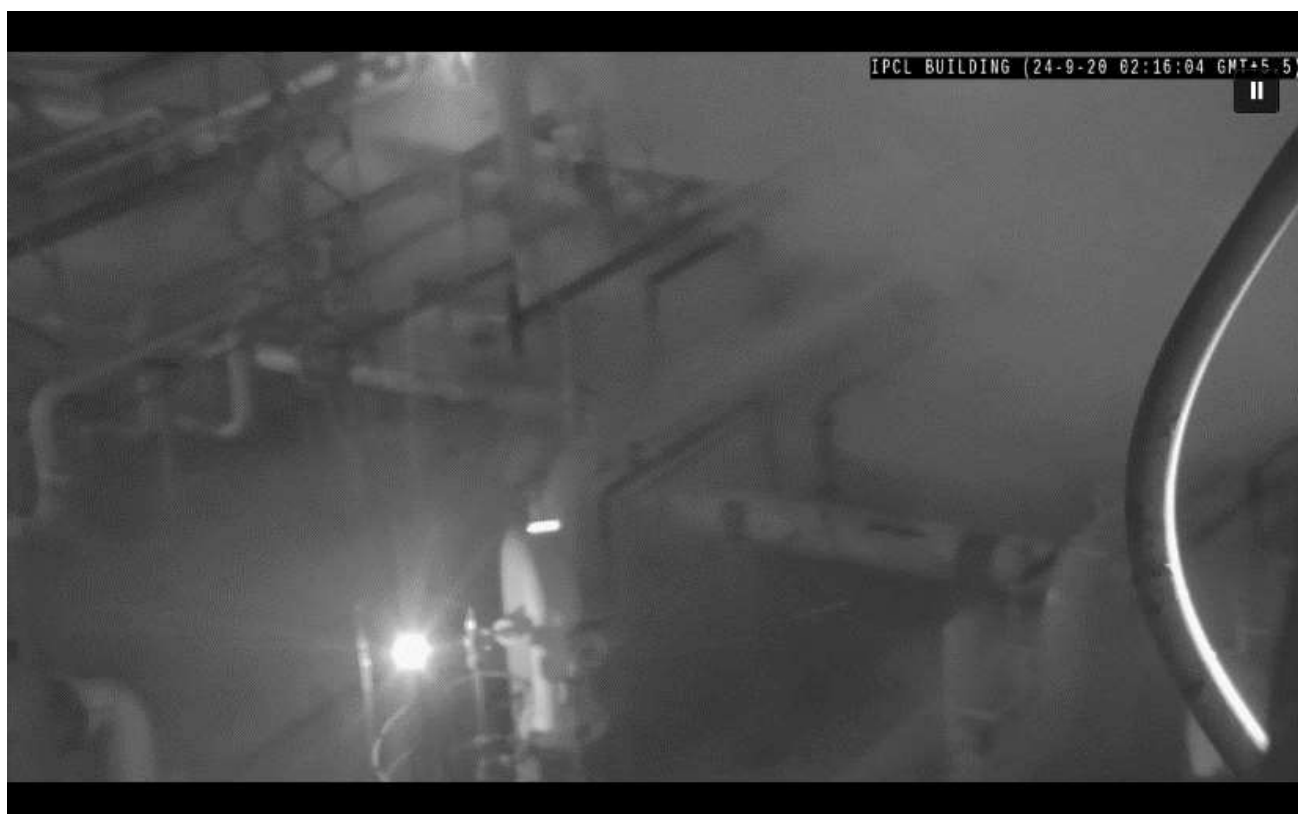
(g). Time – 02:16:04(Dated 24.09.2020), Dispersed vapour cloud

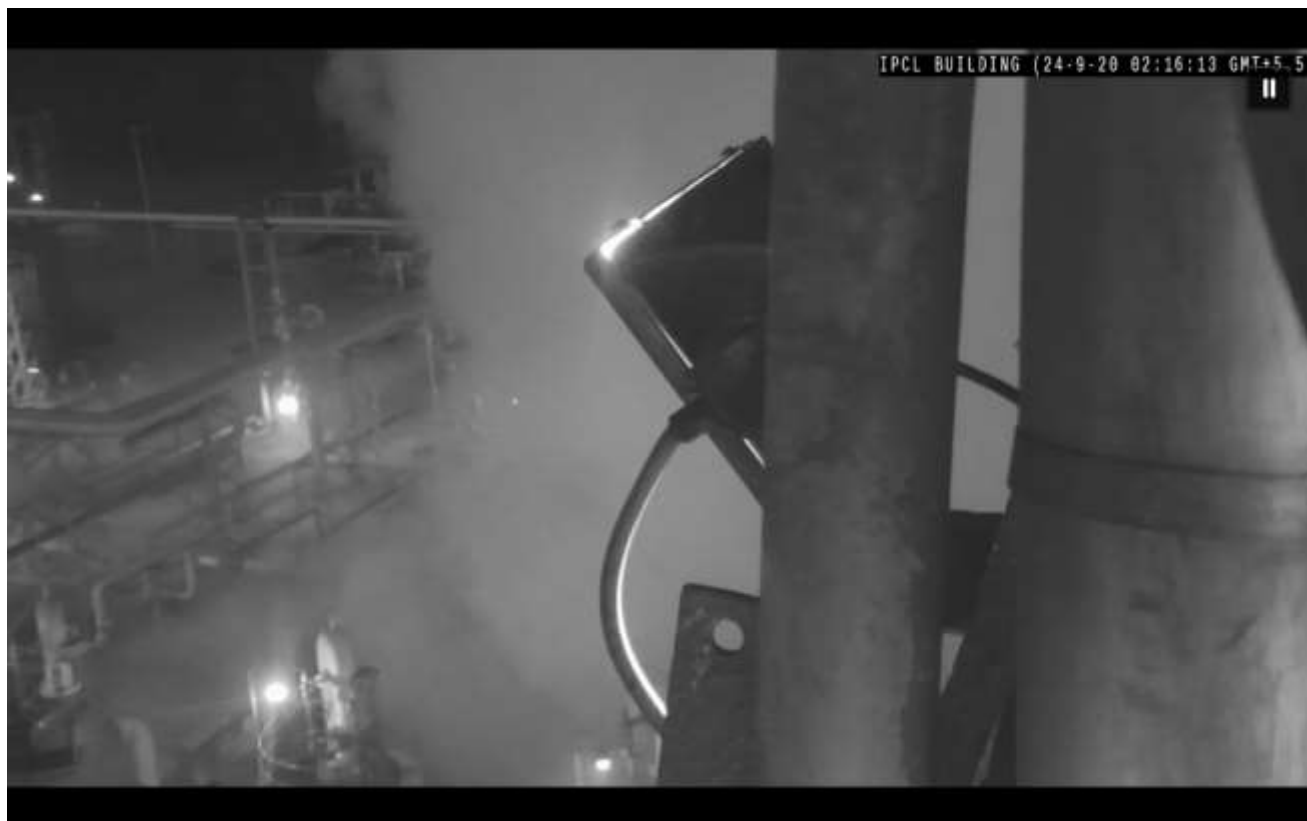
(h). Time – 02:16:13 (Dated 24.09.2020), vapour cloud intense

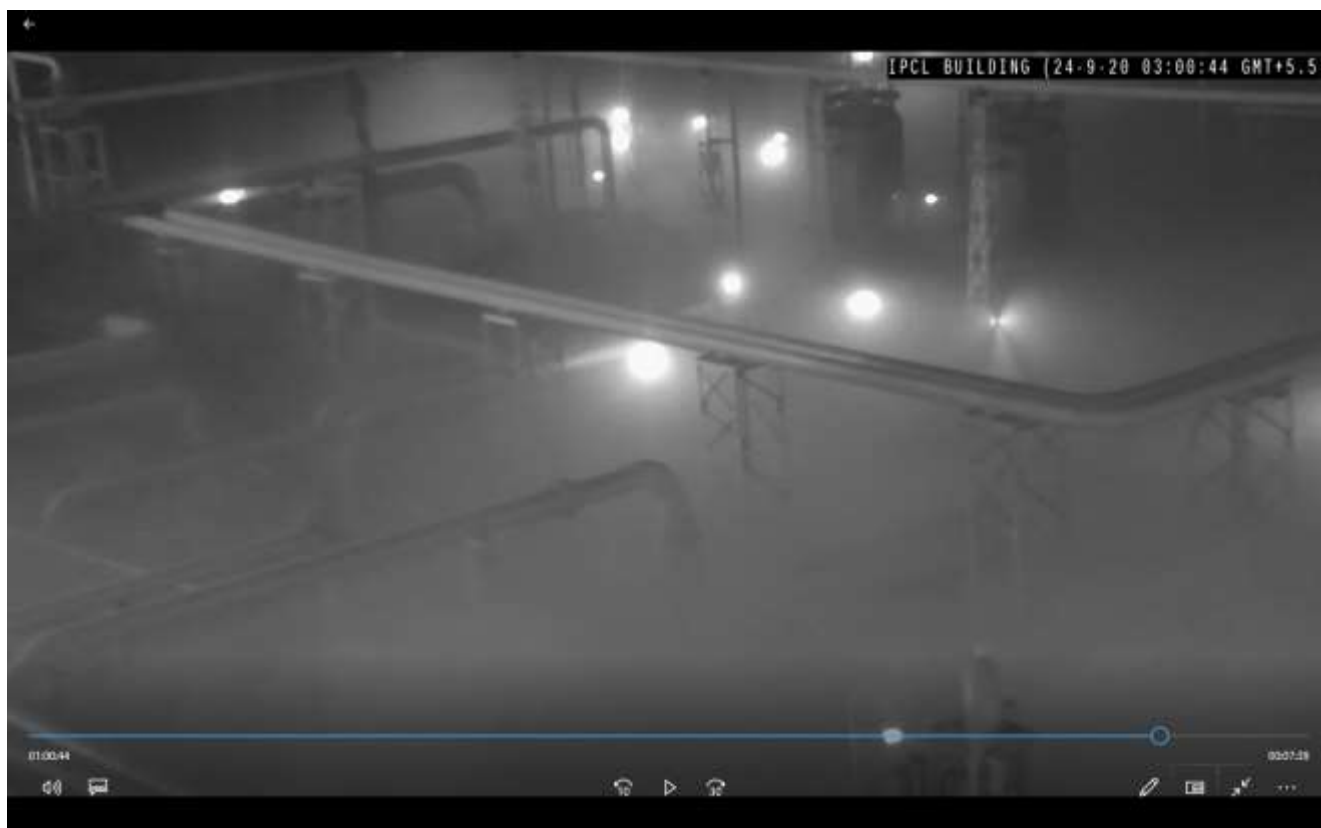
(i). Time – 03:00:44 (Dated 24.09.2020), vapour all around even at height

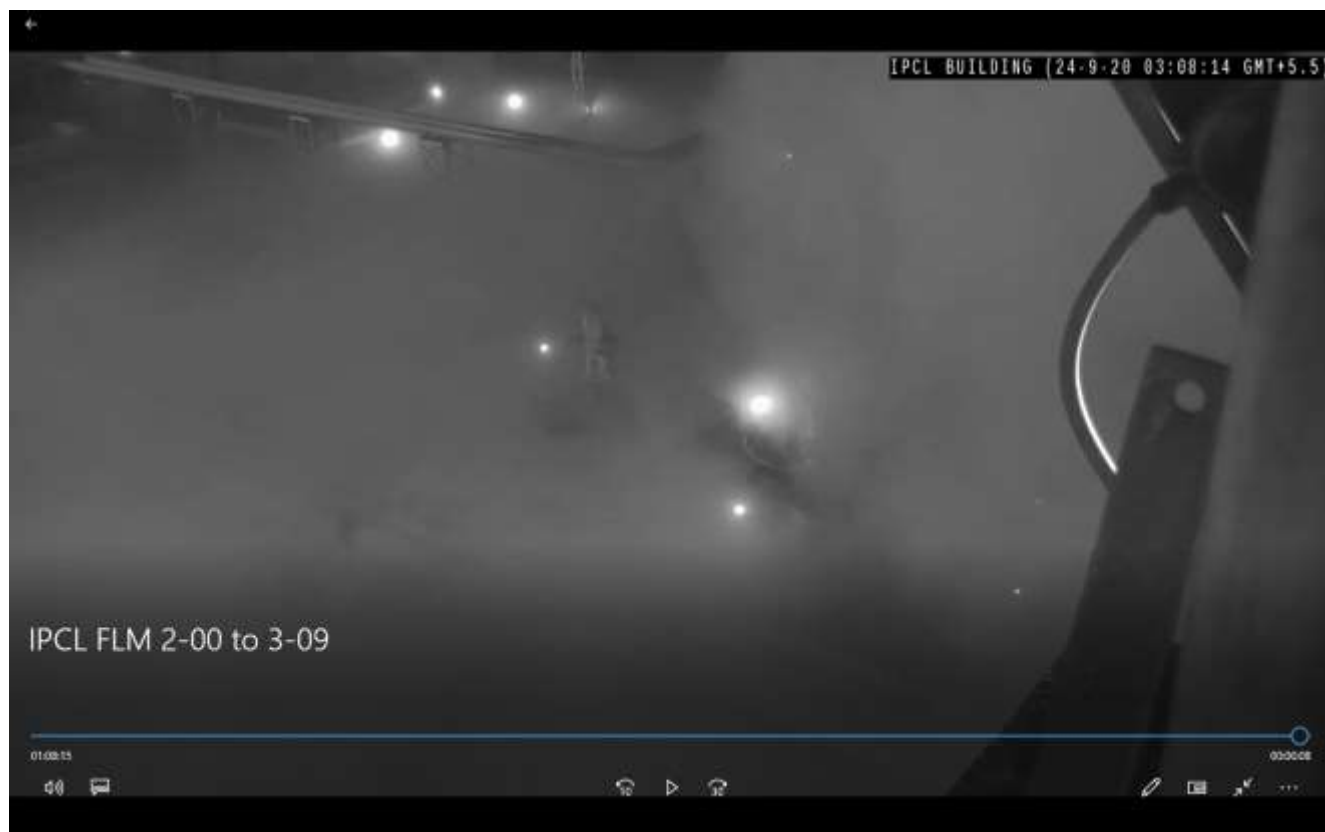
(j). Time – 03:08:14 (Dated 24.09.2020), vapour all around even at height

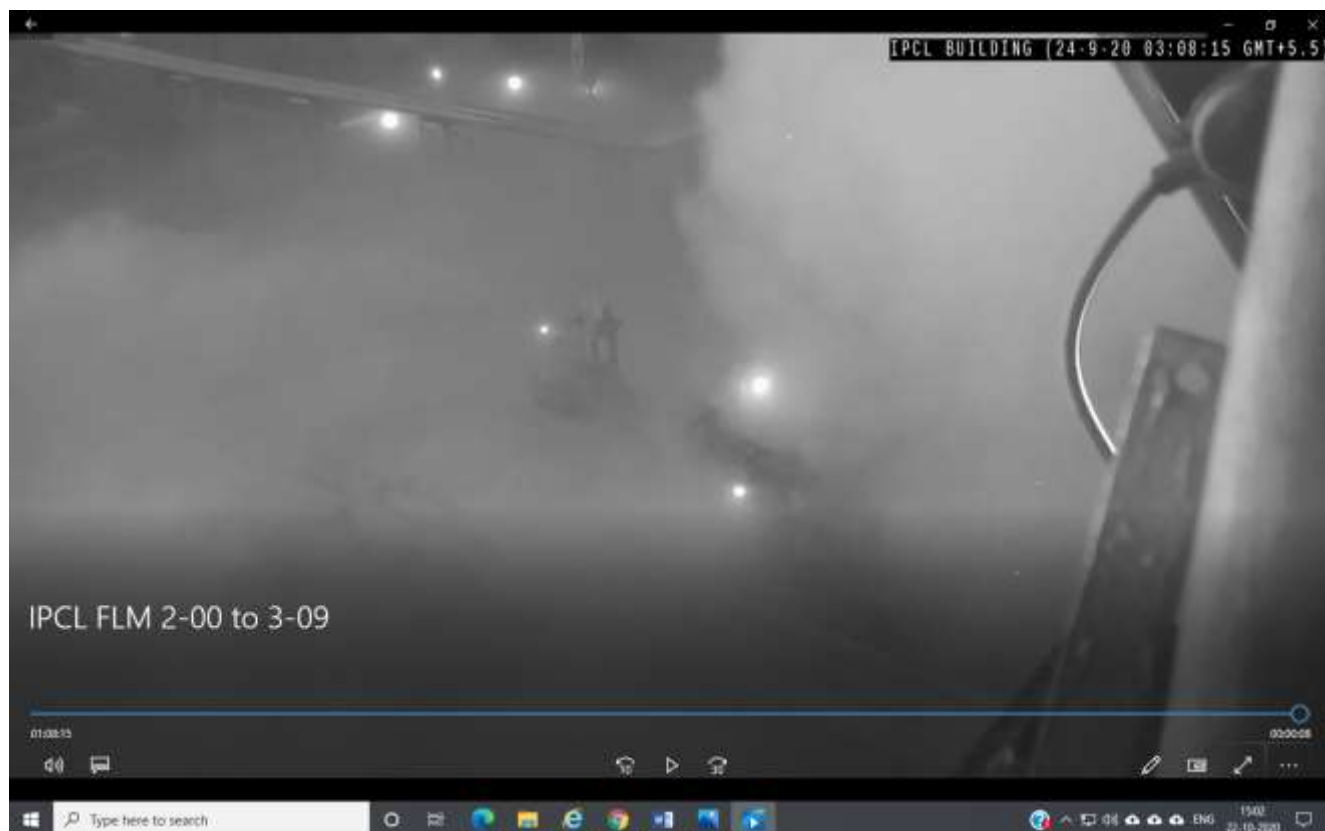
(k). Time – 03:08:15 (Dated 24.09.2020), flash started

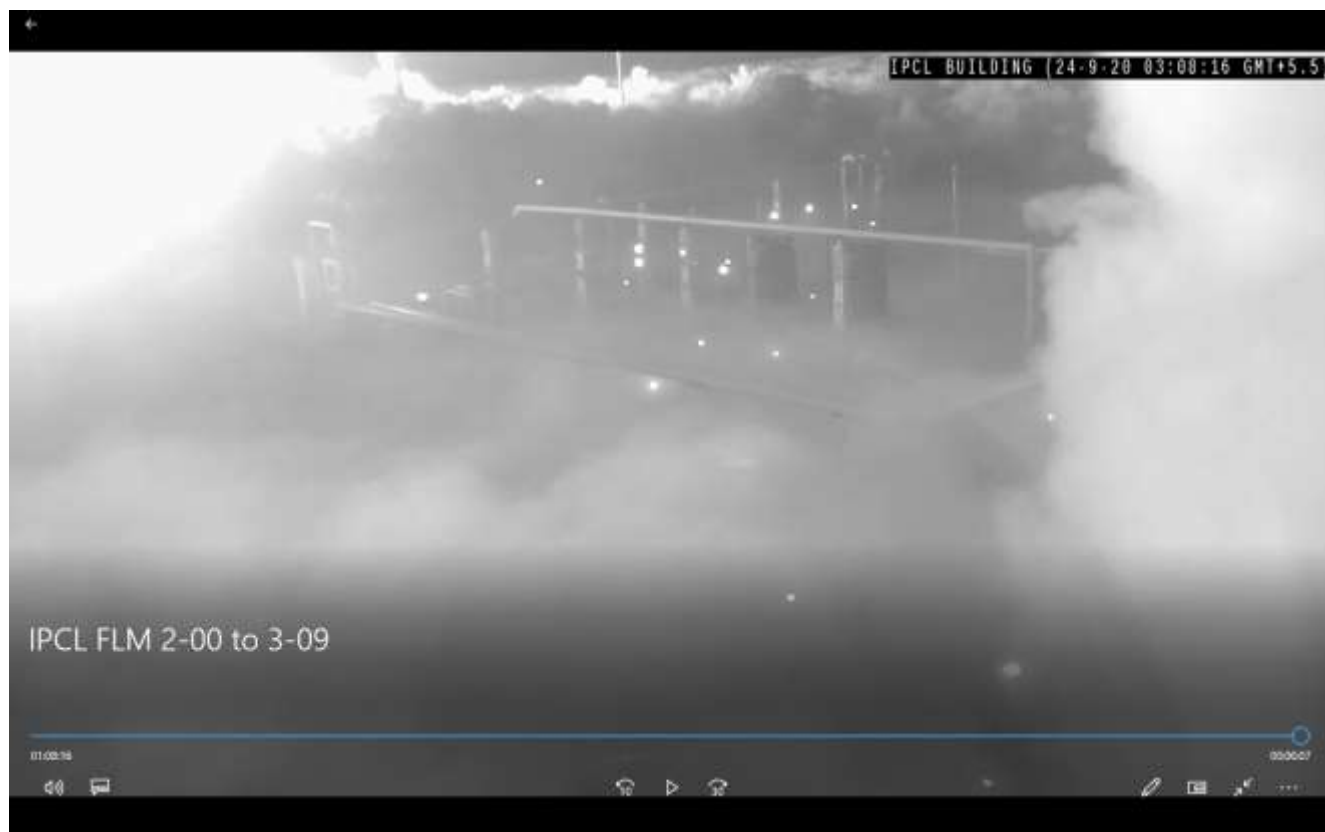
(l). Time – 03:08:16 (Dated 24.09.2020), fire occurred

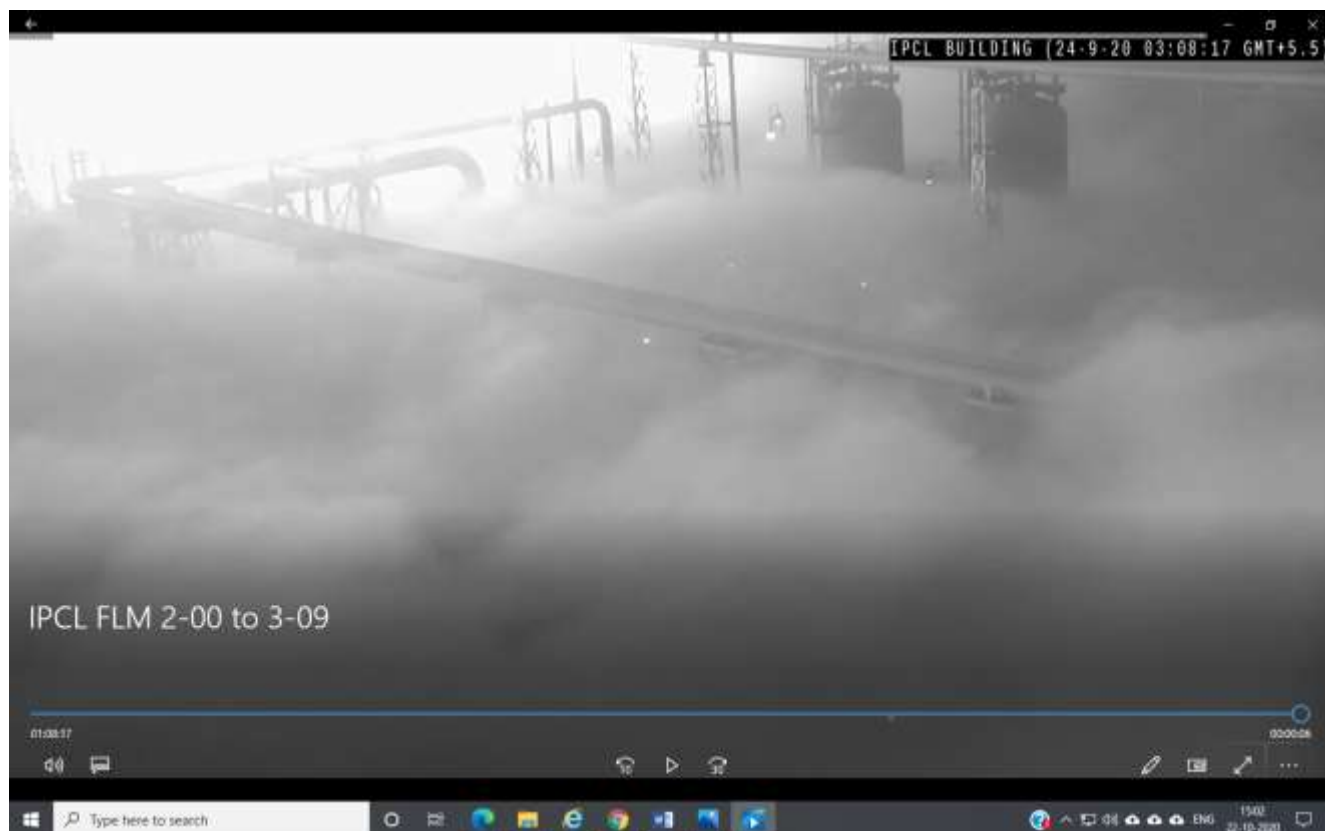
(m). Time – 03:08:17 (Dated 24.09.2020), dense vapour clouds all around

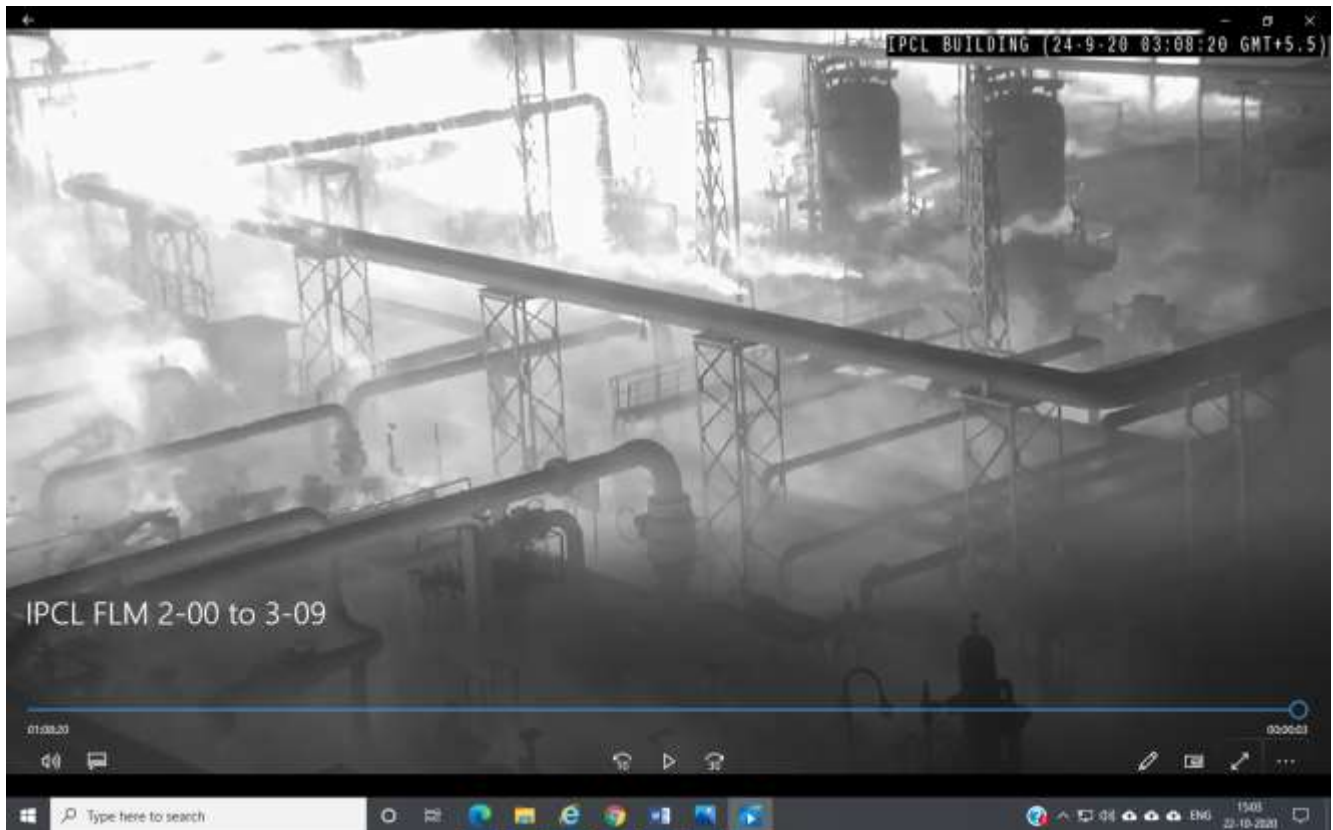
(n). Time – 03:08:20 (Dated 24.09.2020), major fire all around

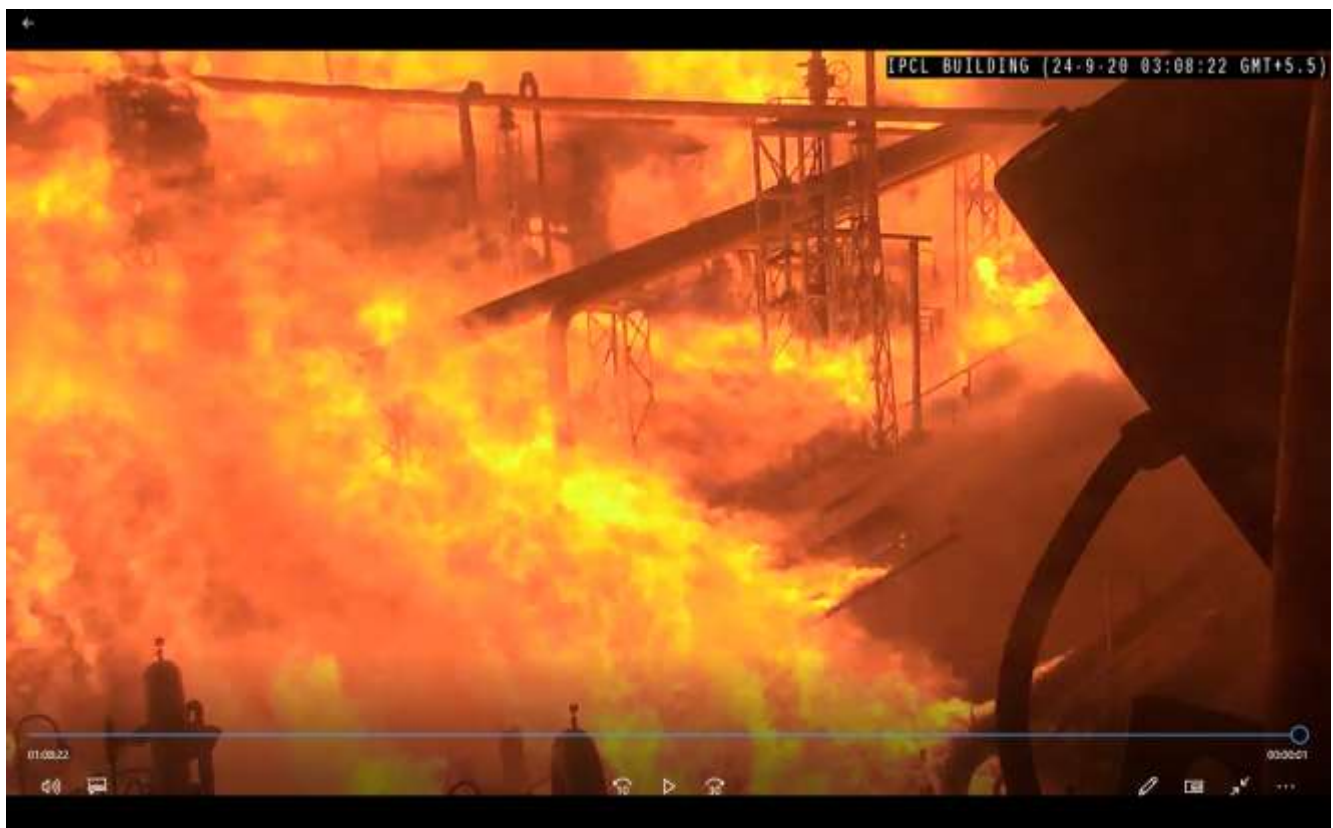
(o). Time – 03:08:22 (Dated 24.09.2020), major fire continued, CCTV capturing discontinued due to burnt of CCTV cable.
