Enquiry Committee Report

**Major Fire at ONGC's Gas processing plant, Uran
On 03.09.2019**

PETROLEUM AND NATURAL GAS REGULATORY BOARD
1st Floor, World trade Centre, Barakhamba Road, Babar Lane, New Delhi-1
Tel No: 011- 23457700/23457744/23457751

Detailed Report of Enquiry Committee constituted by PNGRB to investigate the major fire occurred at ONGC's Gas Processing Plant, Uran on 03.09.2019

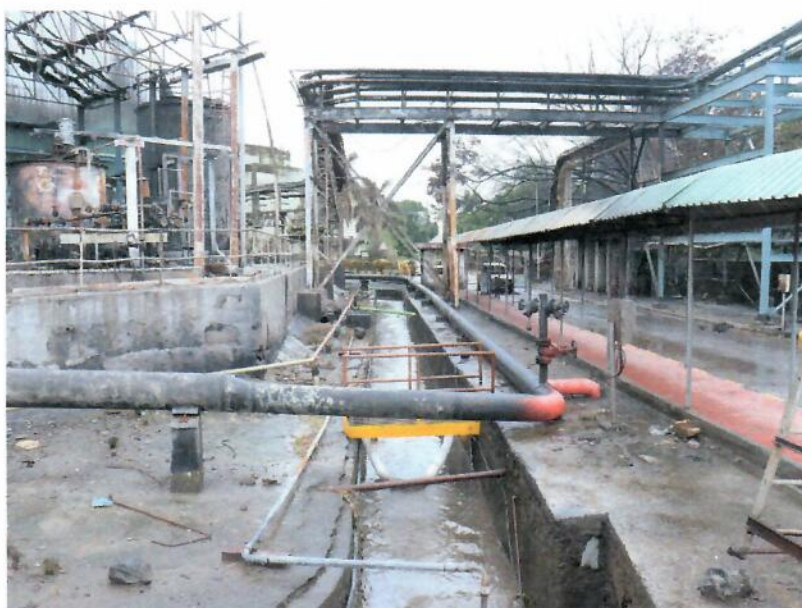
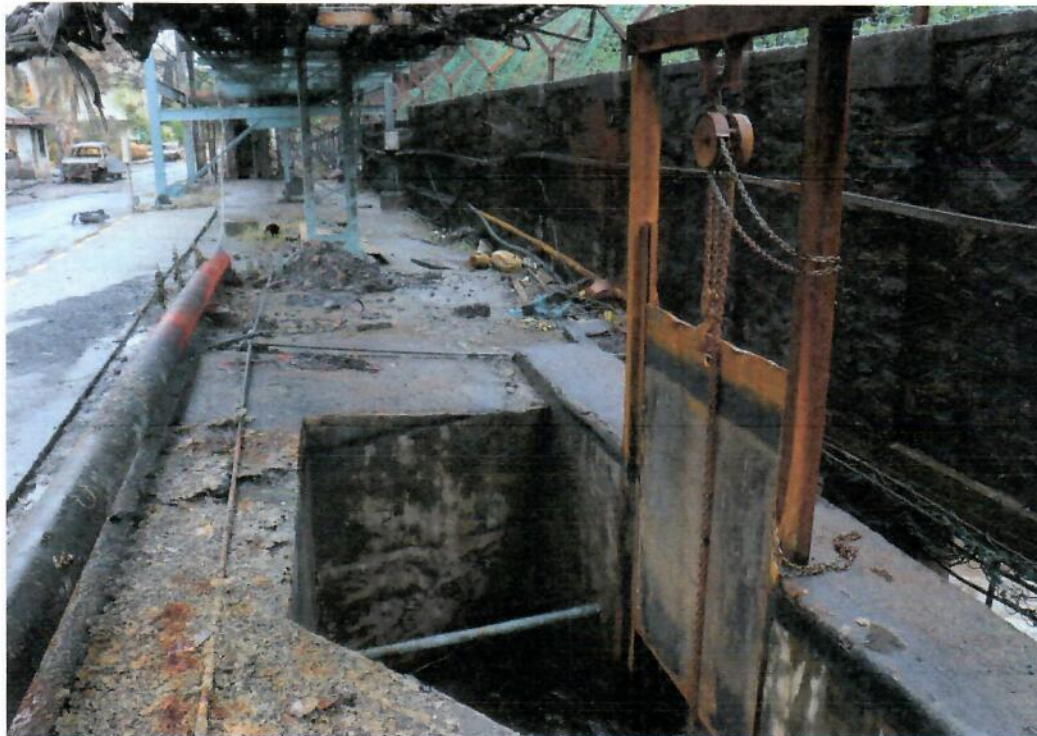
6.1 Road going towards CISF Security cabin near LPG plant Gate (Entry Checking Gate):

This area is marked as Area No. 850 in the plot plan (Annexure 4). Storm water channels from two sides merge here and crosses the road from where it goes outside the boundary of the plant after passing through a sluice gate.

Lot of HT Cables are running through overhead cable tray along and across the road.

The electrical power cable and instrumentation cables over the Storm Water Channel found in a totally burnt condition along with deformation of cable support trays made of MS material.

Maximum damage to the cables observed at exit point of Storm Water Channel near the boundary wall and burnt mark on the wall and sluice gate of the drain. However, the power cable passing through water inside the drain was intact.

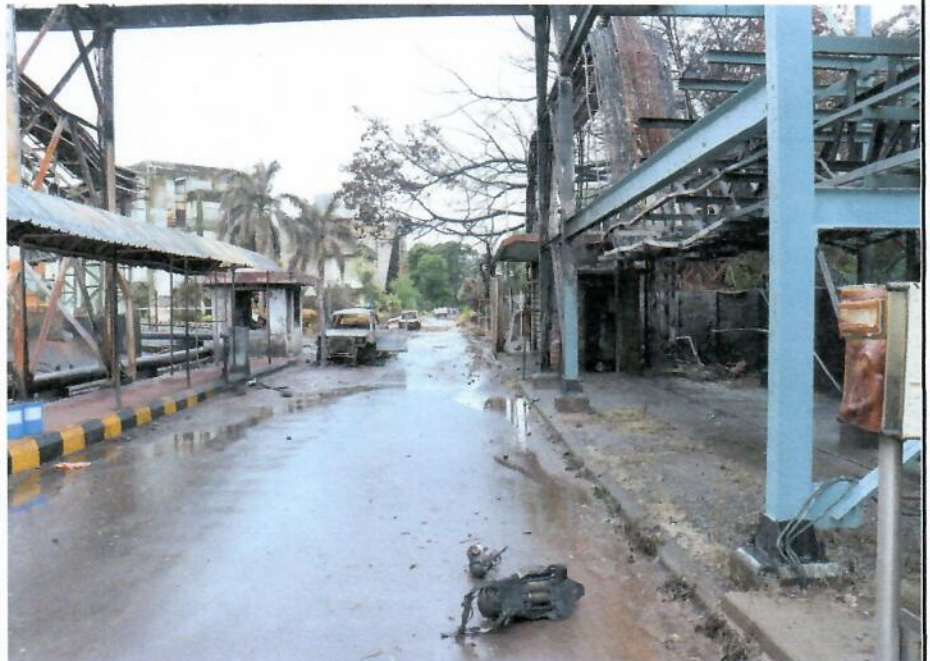
Entire CISF Security cabin with roof was burnt due to fire. Shattered glass pieces of windows were spread on the floor. FLP Telephone along with electrical cable was totally burnt in fire.

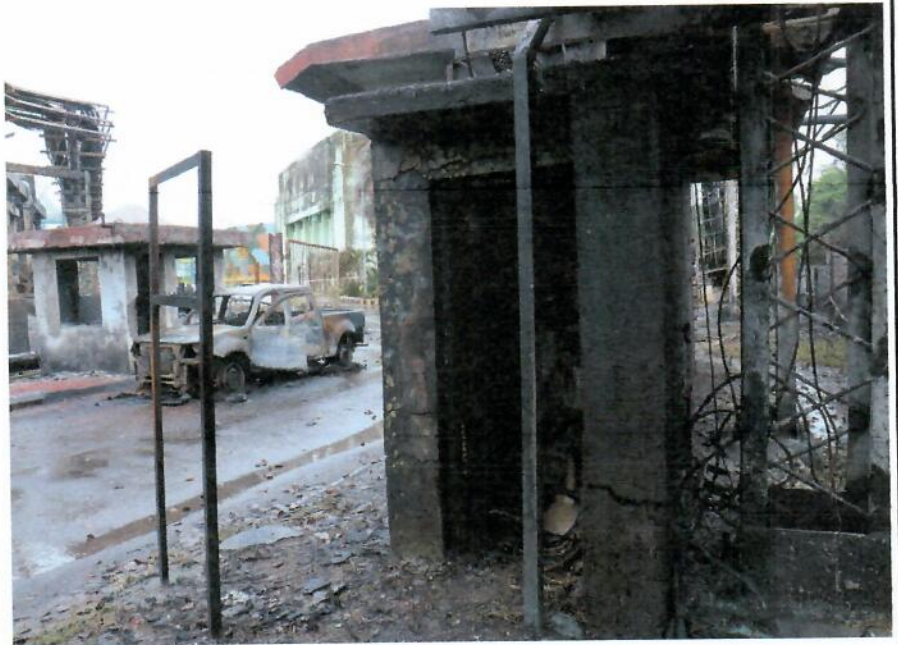
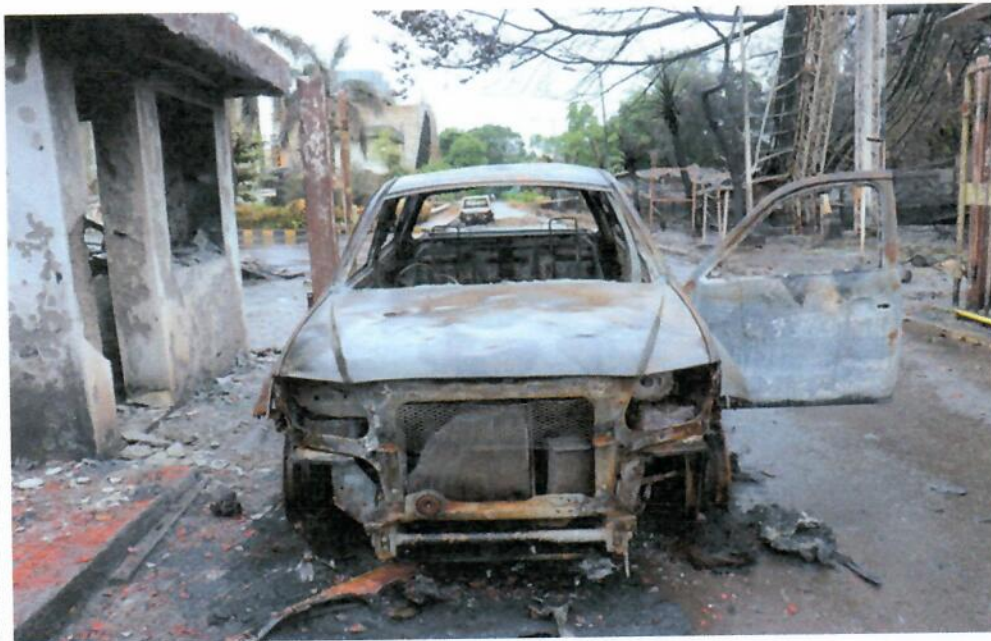
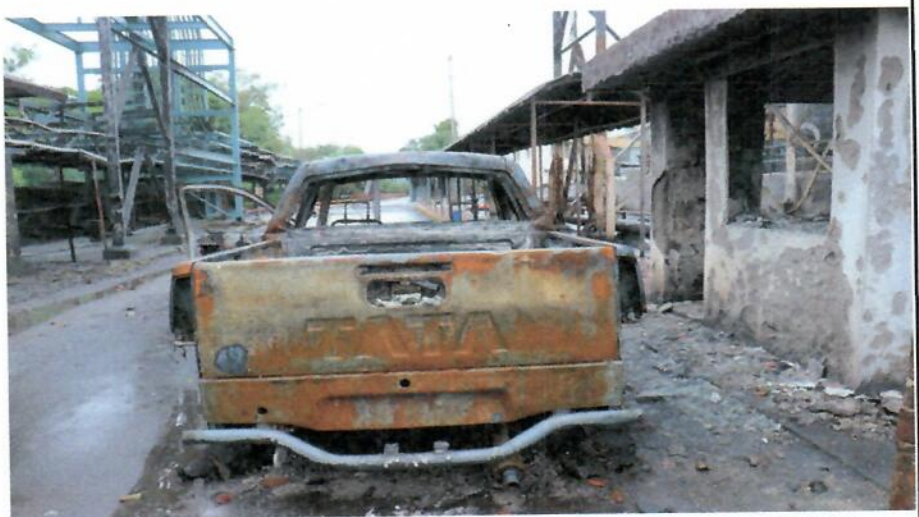
CISF vehicle (Say: Car No. 01) was lying totally burnt in front of security cabin near LPG gate with its hand break in "Applied" position, but without the ignition key. The vehicle was having spark arrestor attached to it.

One number Air cylinder was also lying in totally burnt condition in the car. Dead body of one deceased was recovered from this car during rescue operation.

- d) Spark arrestors to the vehicle: its design, quality check to be done by authorised agency periodically (every 6 months).
- e) Frequent cleaning of the drain leading to sea during rainy season. Also outlet near the boundary wall to be widened. It was found out that the cleaning of OWS pit has not been done since its construction in 2014 and pit bottom could have accumulated sludge and dirt. Due to presence of sludge, the actual liquid handling capacity of the pit may have been reduced which was envisaged in the design. This will result in erroneous figure of the level transmitters. Hence, it is suggested for cleaning of the OWS pit on the regular basis.

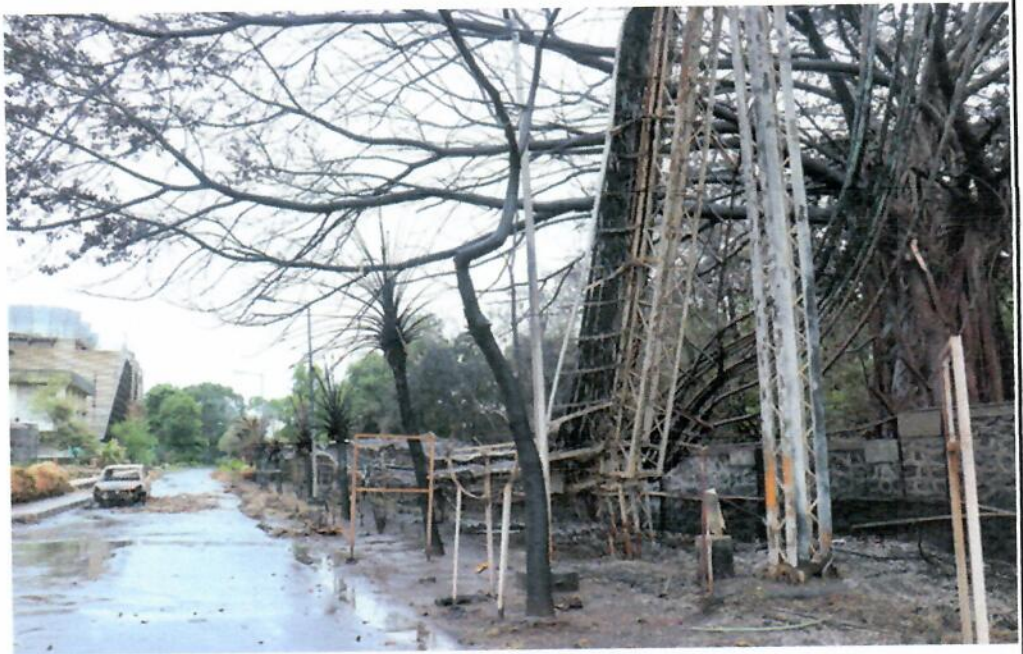
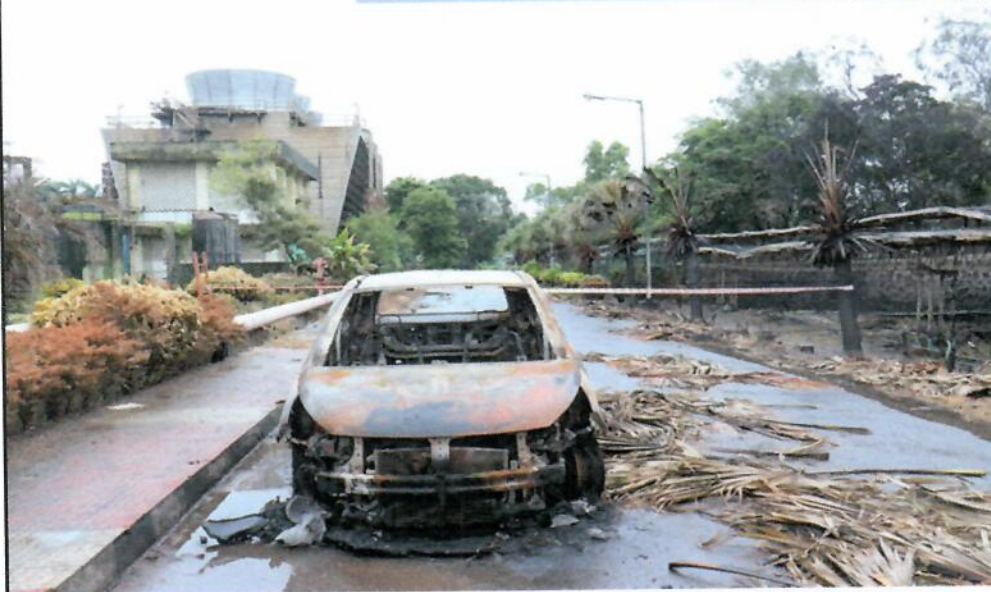
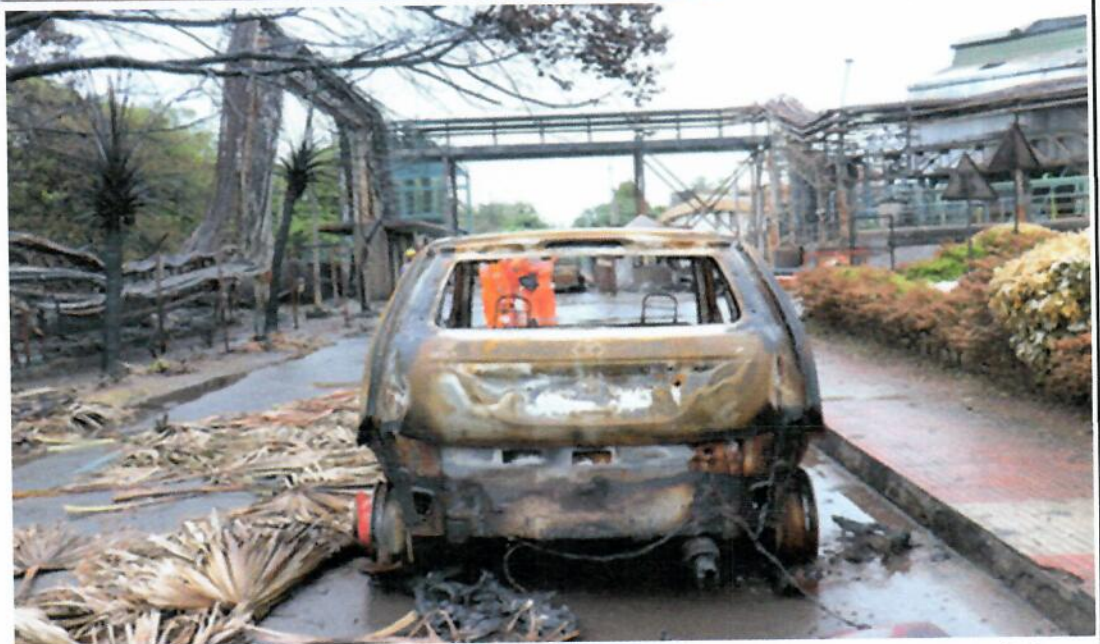
Another vehicle (Say: Car No. 02) was lying around 30 meters behind the car No. 1 in totally burnt condition.

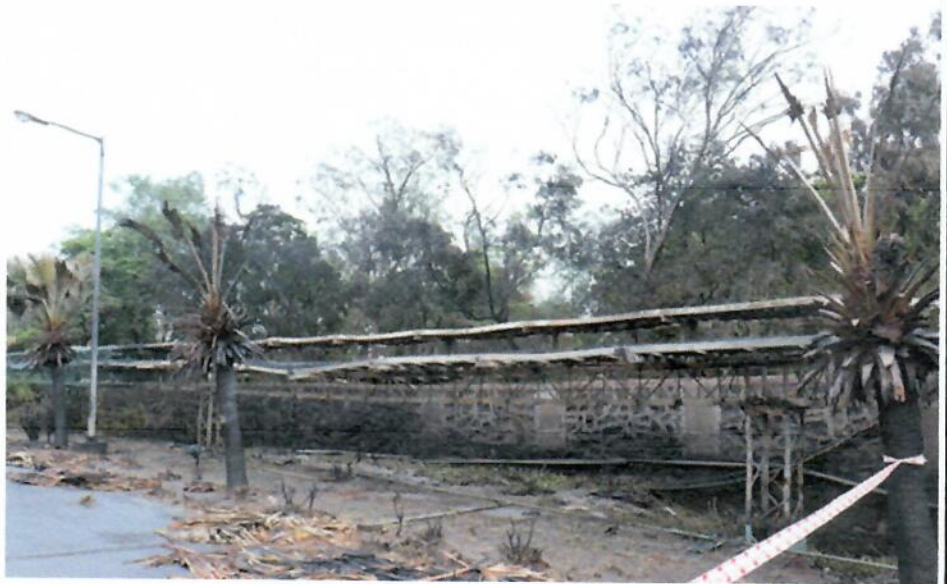
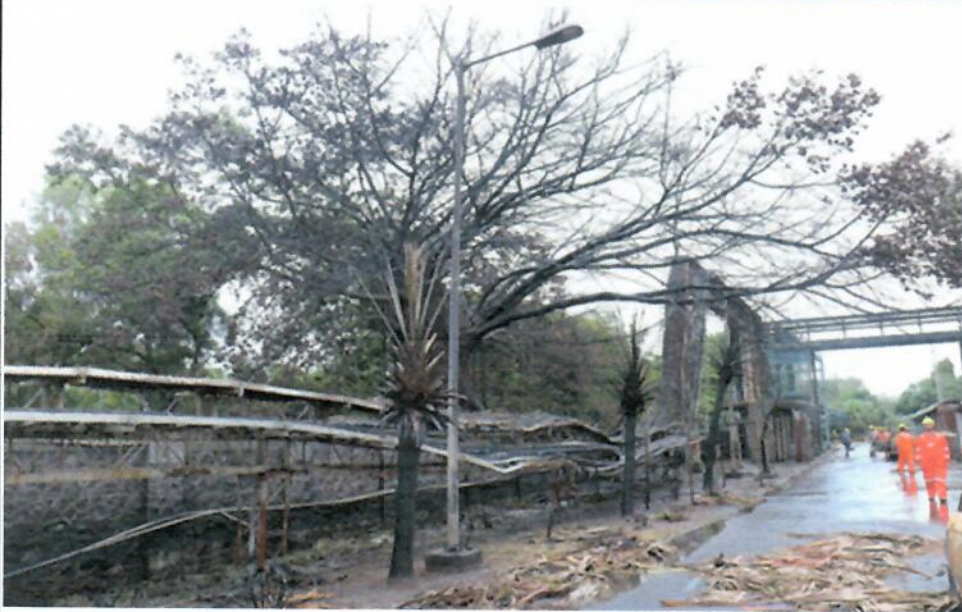
In addition, all plant and trees along the road near LPG gate area were totally burnt. One breathing apparatus (BA) set was also lying in burnt condition on left side of the road.

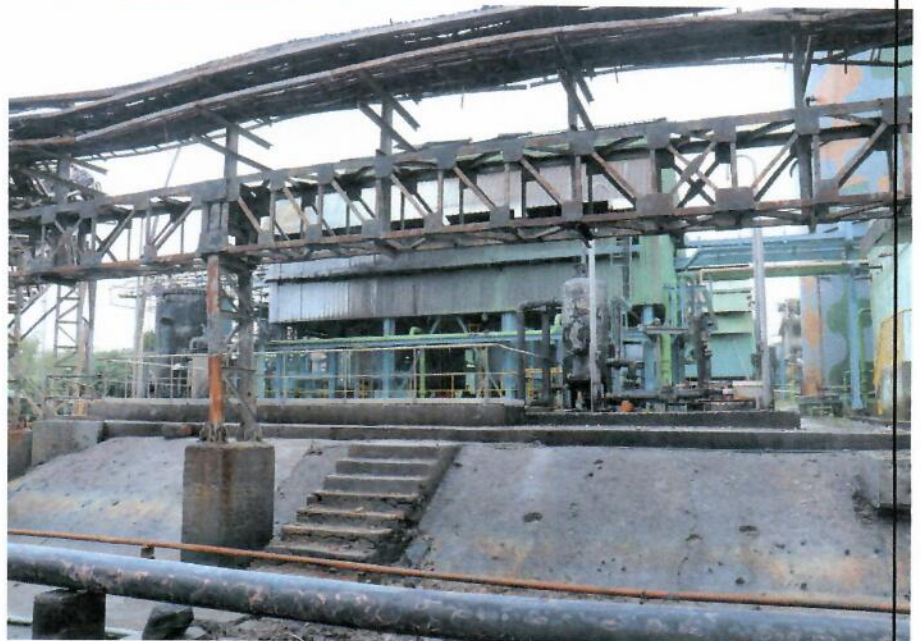
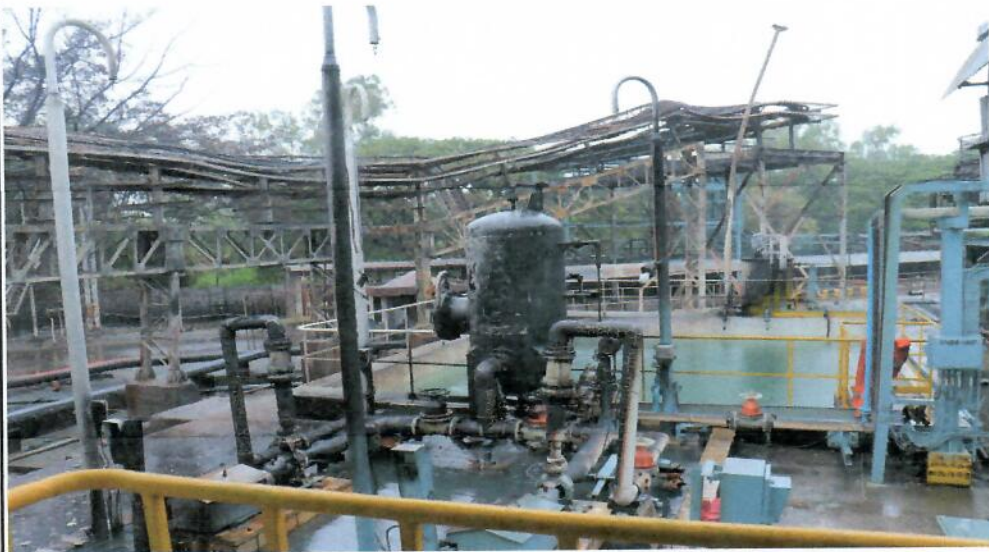
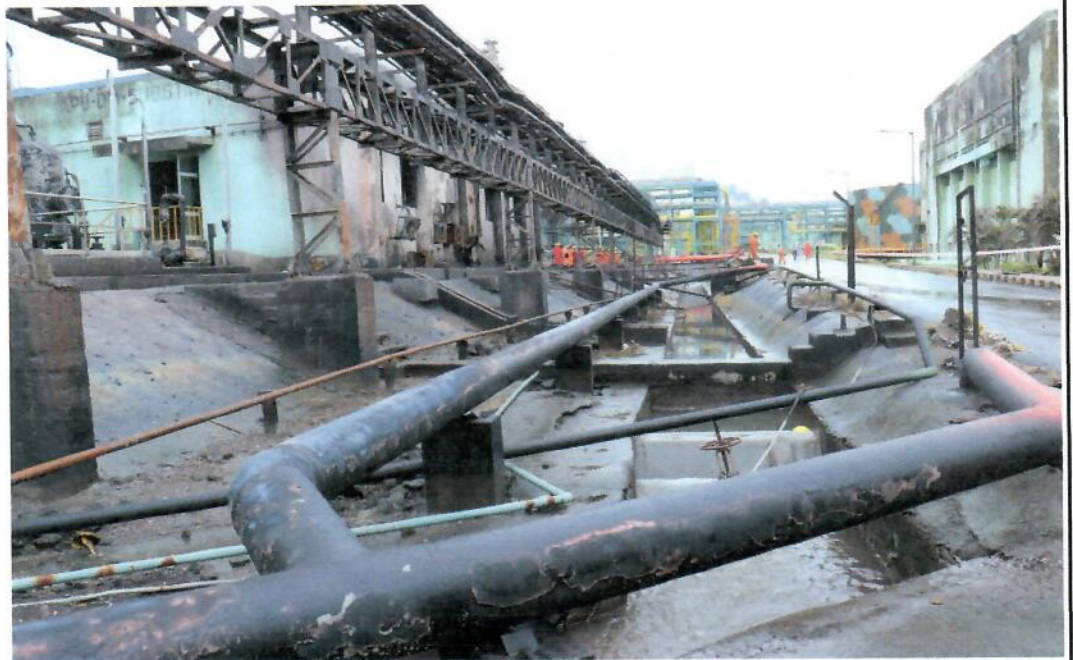
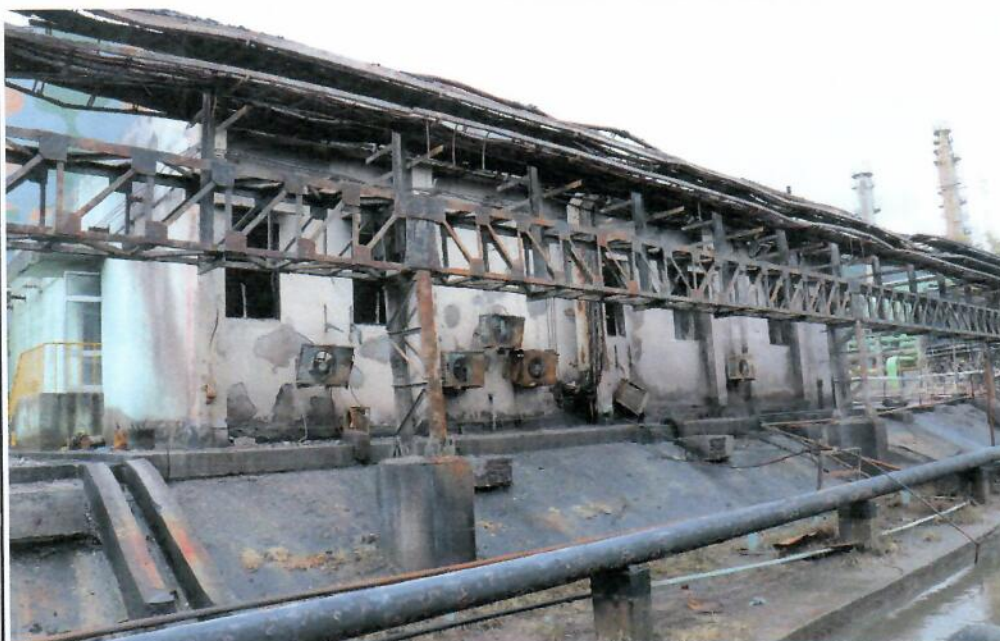
6.2 DM Plant and its peripheral areas: This area is marked as Area No. 952 in the plot plan (Annexure 4). Most of the vessels, pumps, entire polymer shed of the plant, and all the control panels inside the Operator room were burnt. Entire operator room was blackened and covered with carbon soot powder from inside. All the electrical and instrumentation cables found to be 100% burnt.

The origin of fire from an area near DM plant/LPG gate could be seen. The fire further spread towards OWS pits and remain concentrated there for long time. The heavy damage of DM plant area may be indicating that the origin of fire could be from the DM Plant.

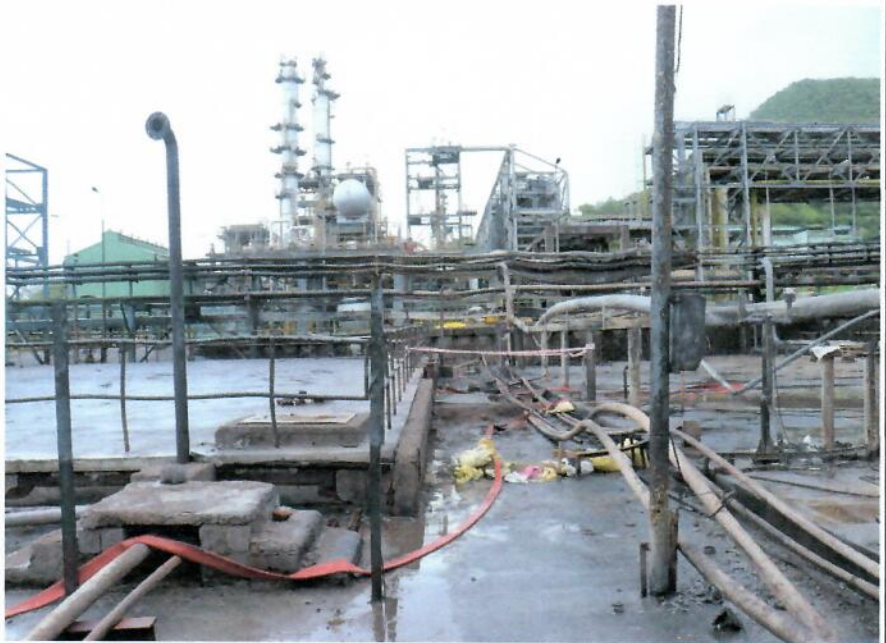
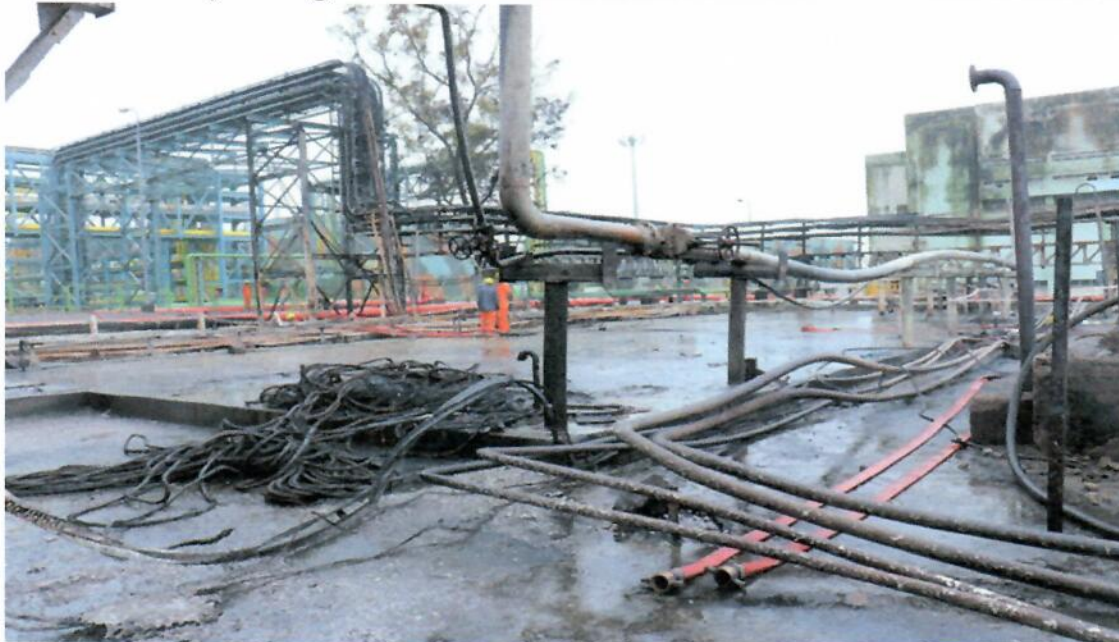
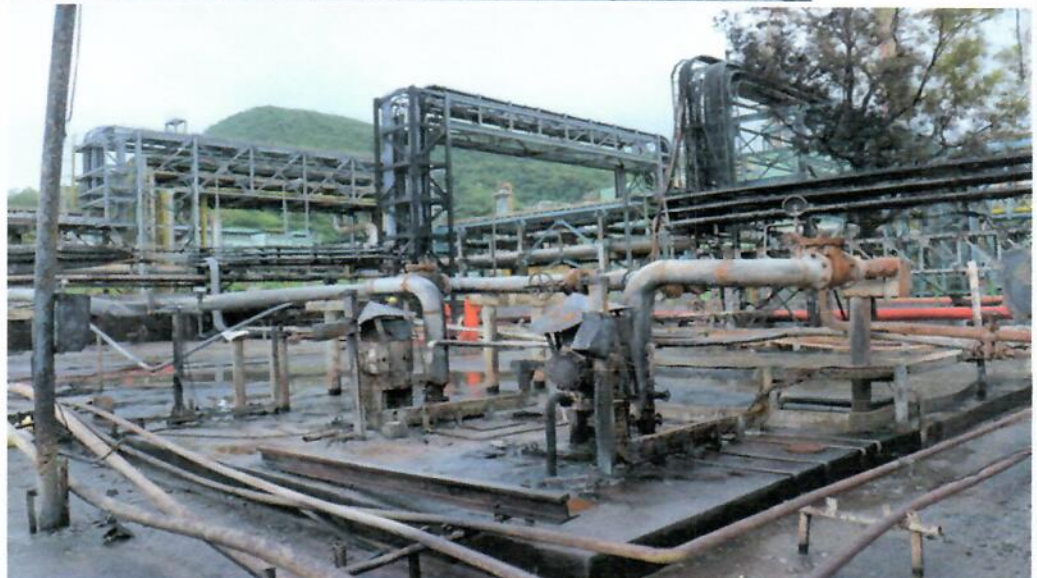
6.3 OWS Pit and pumps:
Both OWS pits of APU and C&C3 Plants were found totally burnt. Two Nos. Submersible pump of APU pit were found completely damaged along with its local control panel, accessory and cablings. Similarly, discharge pipeline was found to be in bend position due to excessive heat. Entire process cable network with its support cable trays were permanently damaged.

The operation of disposal pumps of OWS pits were manual and after checking the level physically, the pumps used to be operated. It was observed that the pumping capacity was much less than the desired capacity. Hence, faster disposal of liquid from pit would require additional time so as to maintain the desired level.

Hence, inadequate evacuation through the pump resulted in overflow of hydrocarbon condensate from these pits, which later on formed dense hydrocarbon vapour cloud along the Storm Water Channel and entire area near LPG gate.

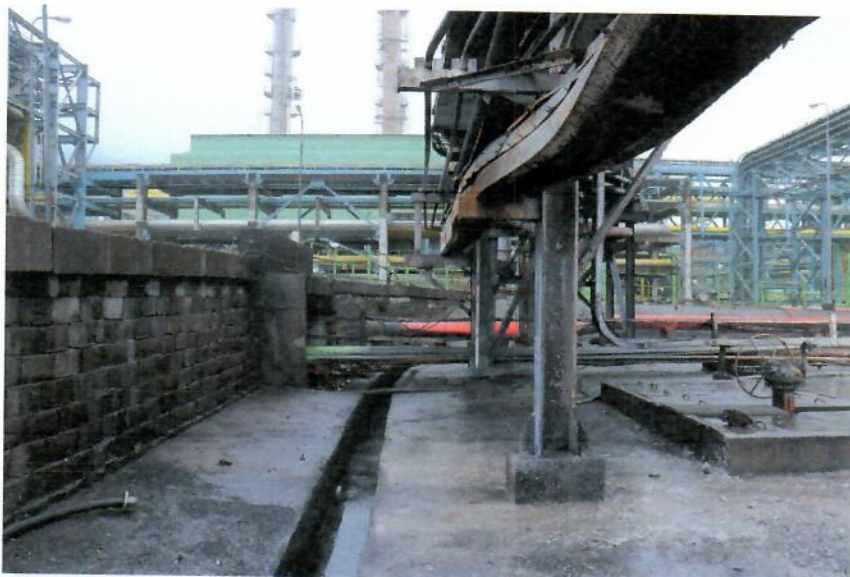
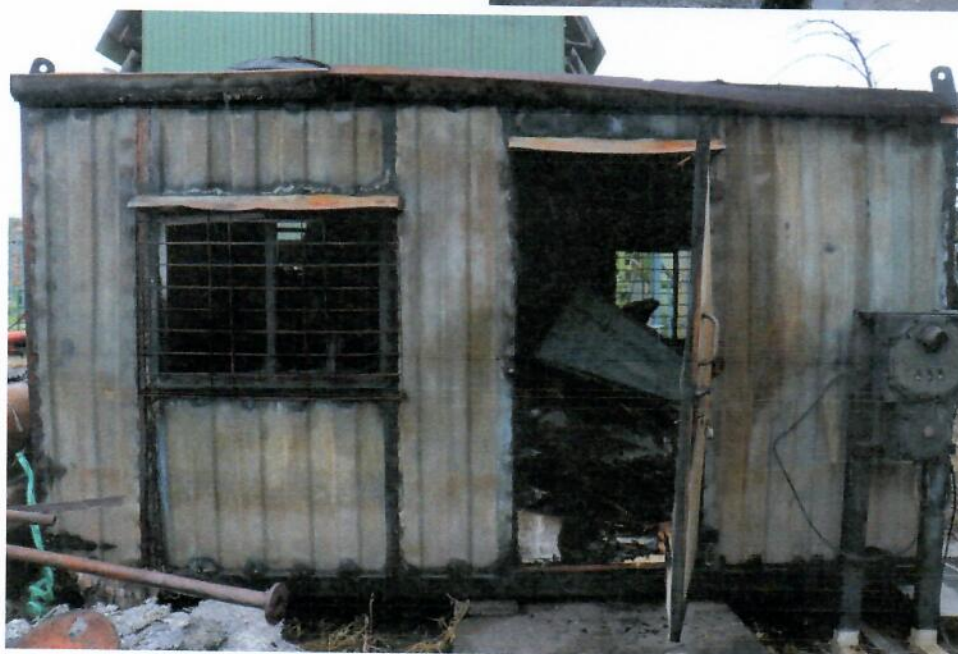
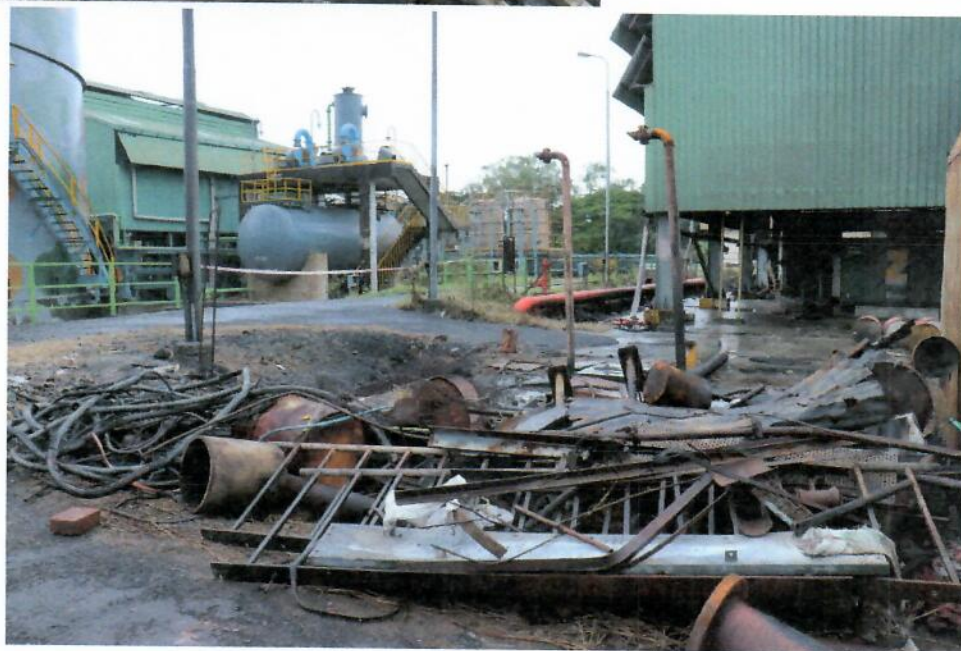
6.4 Condensate Handling Unit (CHU-IV): The fire burnt marks were observed on the support column of CHU and OWS drain pits of CHU. The storage bunkhouse in front of CHU also found burnt along with all the furniture.

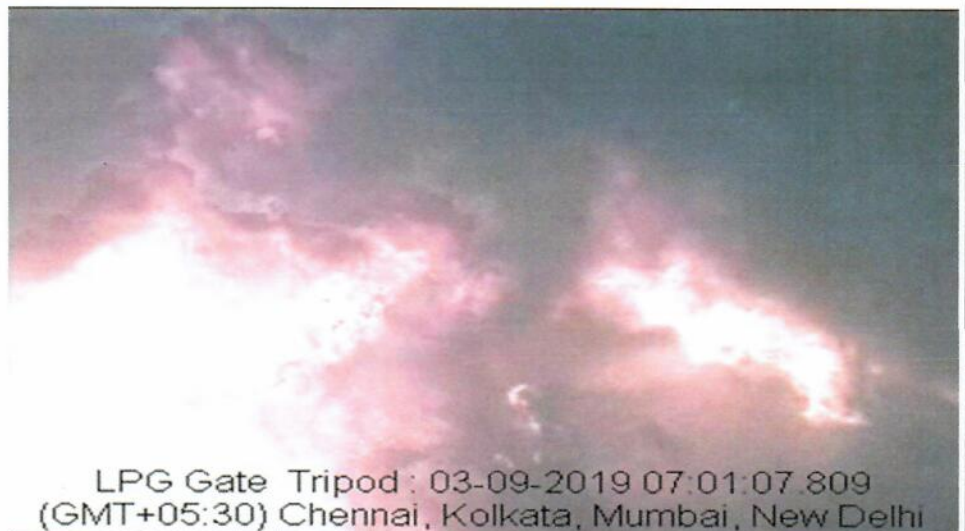
LPG Gate Tripod : 03-09-2019 07:01:07.809
(GMT+05:30) Chennai, Kolkata, Mumbai, New Delhi

f) From CCTV footage, it appeared that the explosion took place in DM Plant and its roof was totally blown. It may also be possible that hydrocarbon vapour cloud got the ignition from electrical spark due to any cable fault or from electrical equipment in DM Plant.
