Enquiry Committee Report

**Major Fire at ONGC's Gas processing plant, Uran
On 03.09.2019**

PETROLEUM AND NATURAL GAS REGULATORY BOARD
1st Floor, World trade Centre, Barakhamba Road, Babar Lane, New Delhi-1
Tel No: 011- 23457700/23457744/23457751

Detailed Report of Enquiry Committee constituted by PNGRB to investigate the major fire occurred at ONGC's Gas Processing Plant, Uran on 03.09.2019

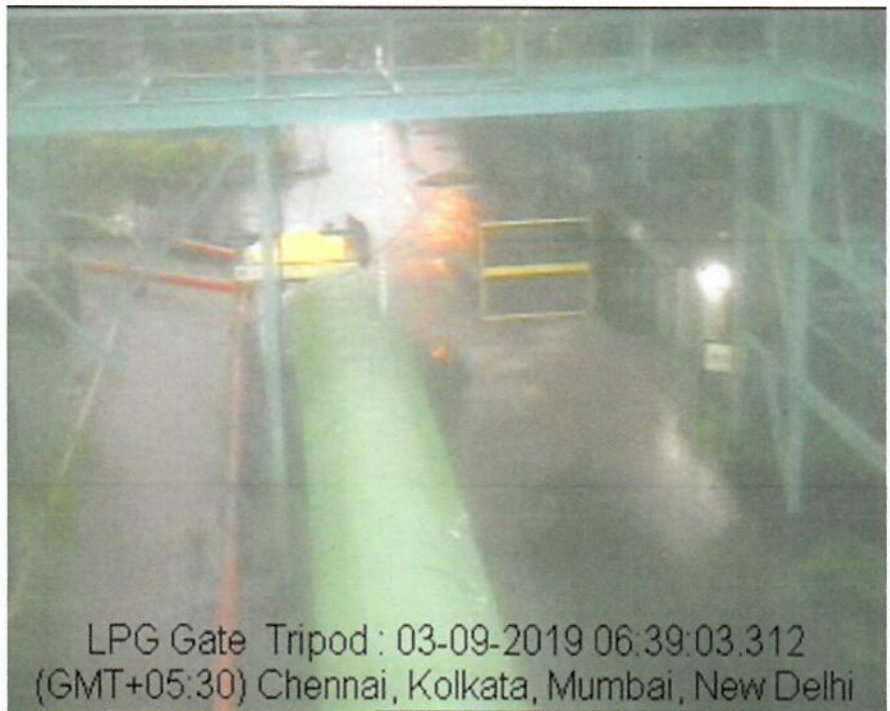
LPG Gate Tripod : 03-09-2019 06:39:03.312
(GMT+05:30) Chennai, Kolkata, Mumbai, New Delhi

(1). **Mr. P J Rama Rao, Constable, CISF:** Mr. P J Rama Rao was posted at LPG Gate in the morning shift on 03.09.2019. He took over the post from Mr. Ashok at 5.00 am. According to him, everything was normal at the time of charge takeover except it was heavily raining. Both storm water channels from DM water plant and OWS pit sides were overflowing on roads. Around 6.30 hrs., he felt intense smell and breathing problem. When it became unbearable, he called the security control room to send his replacement, as he was not feeling well due to breathlessness.

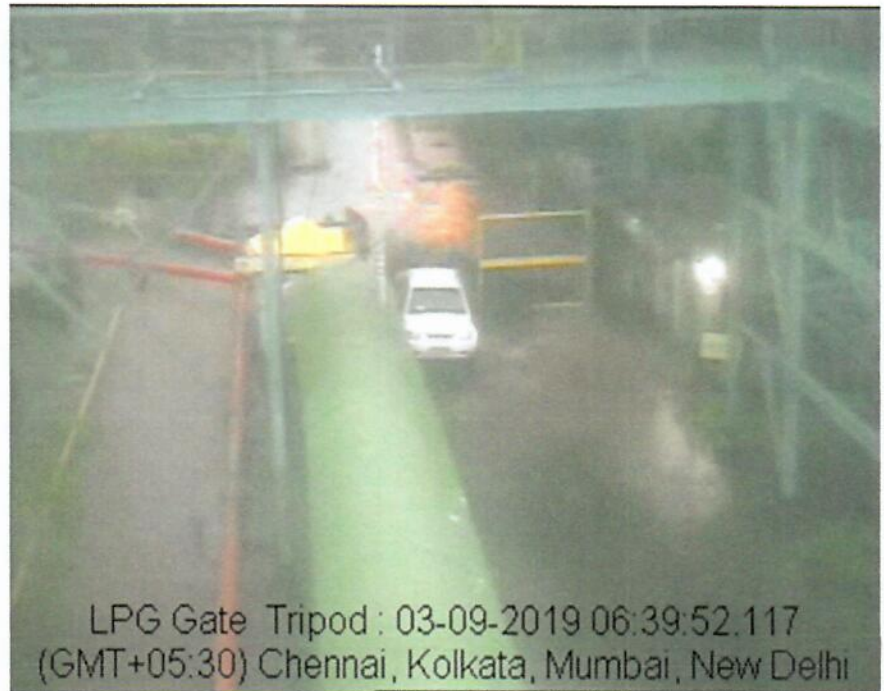
LPG Gate Tripod : 03-09-2019 06:39:52.117
(GMT+05:30) Chennai, Kolkata, Mumbai, New Delhi

(2). **Mr. Digvijay Singh Baghela, Mr. Mohammad Akhlaque, Mr. Hari Om Yadav:** These three persons were part of CISF - STF team. After getting instruction from security control room, all the above three persons moved from NGL gate side in STF vehicle (Car No. 01) to see Mr. P J Rama Rao posted at LPG gate.

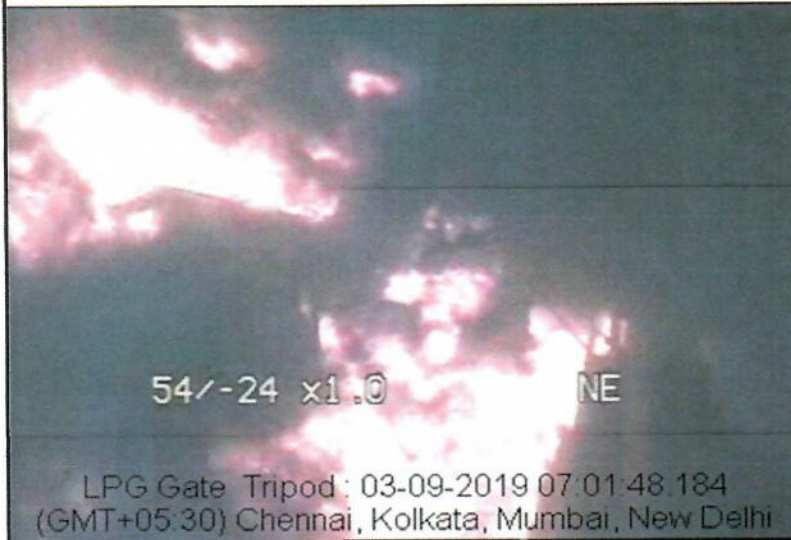
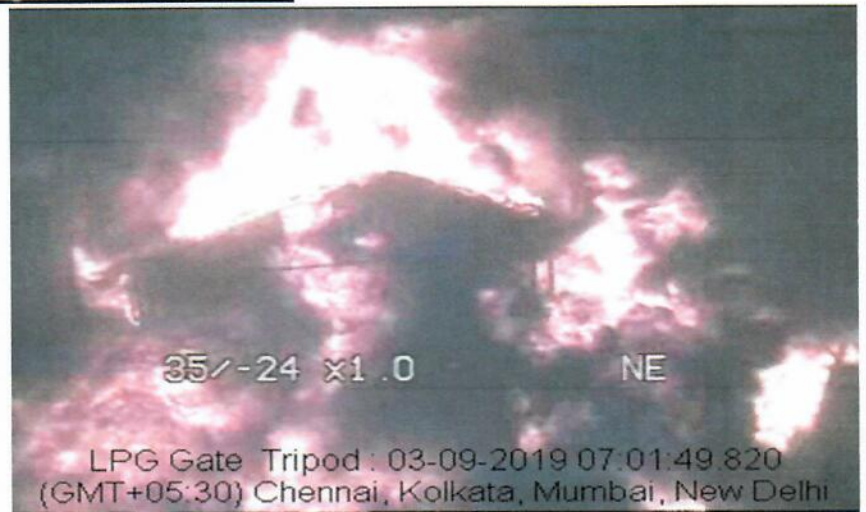
g) From CCTV footage it was observed that one of the crew member of fire tender entered several times in the stranded vehicle (car No. 01) while they were planning to shift that vehicle for clearing the road. It may also be presumed that the crew member would have also tried to restart the vehicle. Knowing fully well that they were inside the hydrocarbon vapour cloud, such action could have led to explosion.

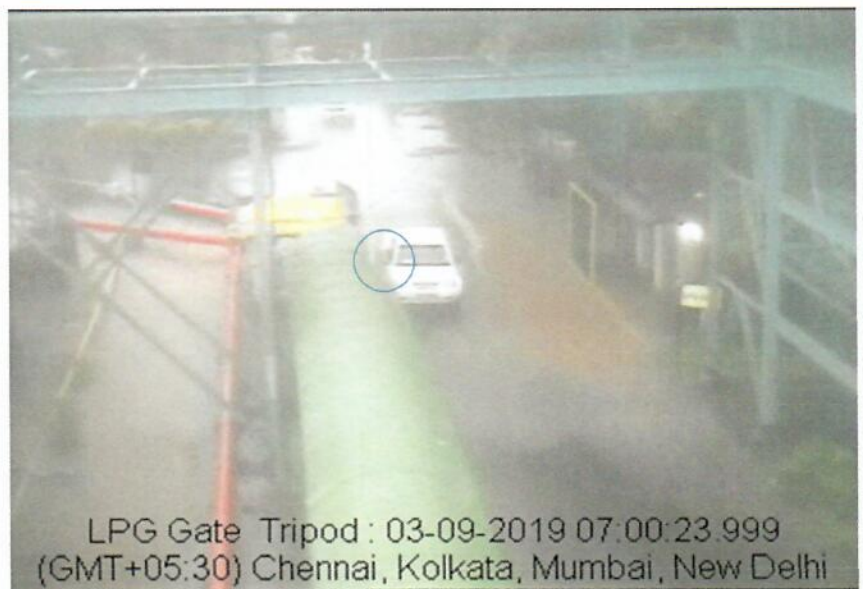
h) In addition, record of regular check of spark arrestor of vehicles operating inside hazardous area was not available or practised. Breathing problem faced by CISF guard at the gate (Sri PJ Rama Rao at around 6-32AM) was another example of presence of rich

hydrocarbon mixture in the air at the vicinity of the security gate. Though he complained about breathlessness but that vital input was not considered in conjunction with the situation (over flooding of hydrocarbon etc in the drain) at the ground.
